Mahindra First Choice Wheels Certification Report

2014 HYUNDAI VERNA(2011-2015) FLUIDIC 1.6 CRDI SX AT

Bangalore | 73782 km | Diesel | Automatic | Silver Colour | 2nd Owner

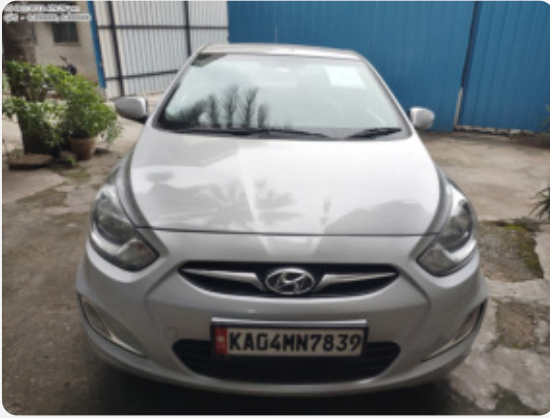
Front Side

Front Bumper

Condition : Satisfactory

Color difference / Some alignment gap

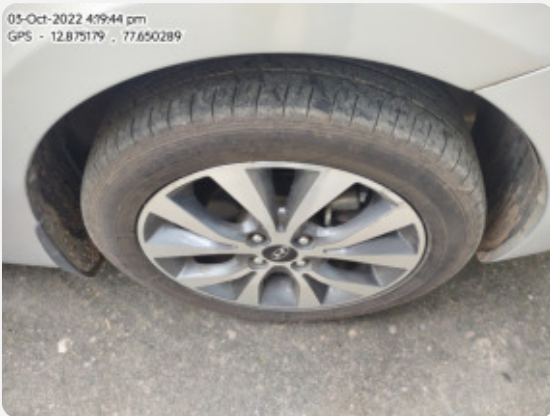
Front Right Tyre

Condition : Satisfactory

Same Make/ Good & > 40% life

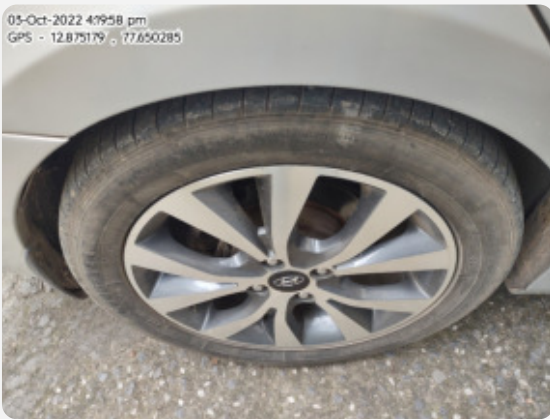
Rear Right Tyre

Condition : Satisfactory

Same Make/ Good & > 40% life

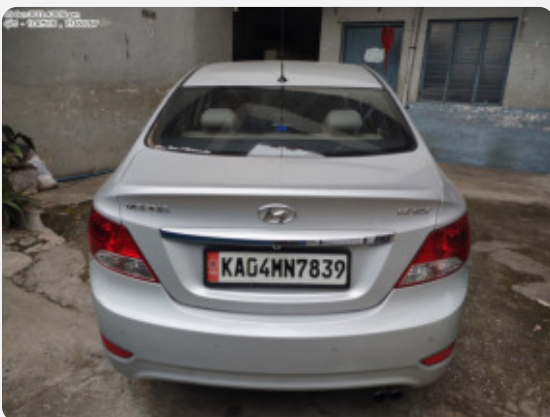
Back Side

Rear Bumper

Condition : **Satisfactory**

Color difference / Some alignment gap

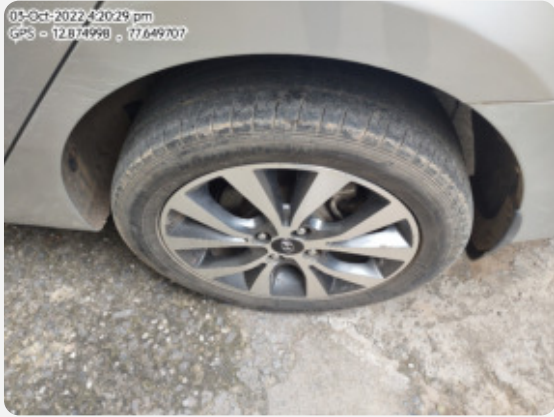
Rear Left Tyre

Condition : **Satisfactory**

Same Make/ Good & > 40% life

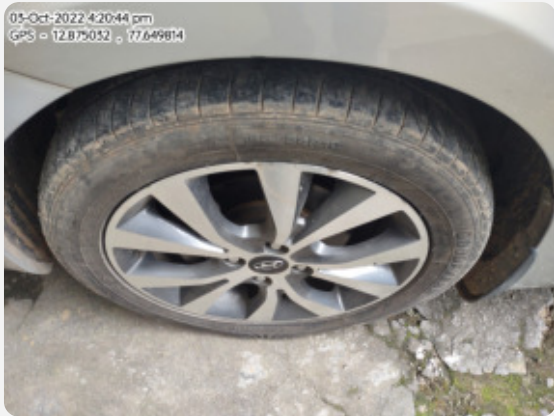
Front Left Tyre

Condition : **Satisfactory**

Same Make/ Good & > 40% life
