Mahindra First Choice Wheels Certification Report

2016 TATA INDIGO ECS(2013-2018) LX TDI BS-III

Allahabad | 47033 km | Diesel | Manual | White Colour | 1st Owner

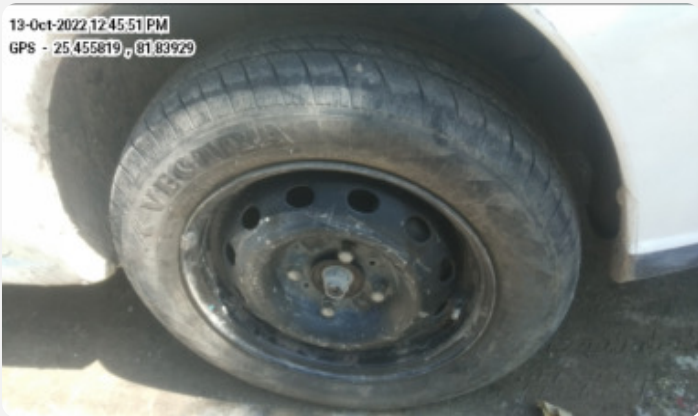
Front Right Tyre

Condition : Satisfactory

Same Make/ Good & > 40% life

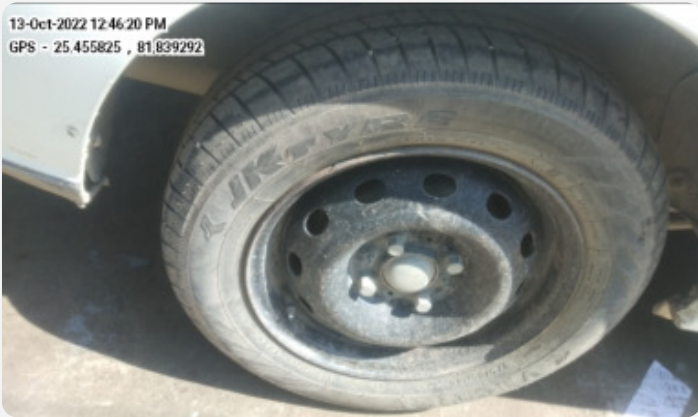
Rear Right Tyre

Condition : Good

Same Make/ Good & > 60% life

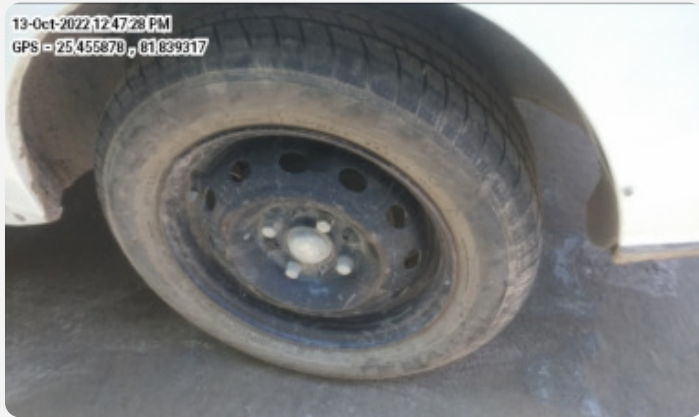
Rear Left Tyre

Condition : **Good**

Same Make/ Good & > 60% life

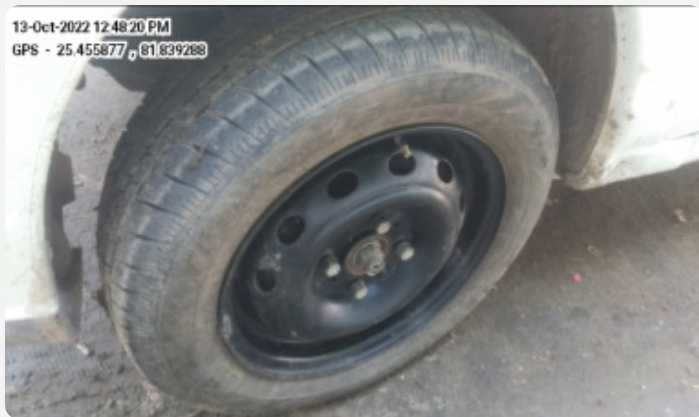
Front Left Tyre

Condition : **Satisfactory**

Same Make/ Good & > 40% life

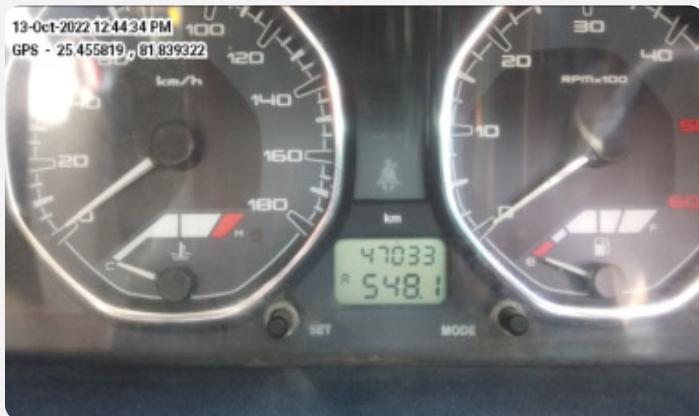
Odometer

odometer tempered
