## Mahindra First Choice Wheels Certification Report

**2014 MARUTI SUZUKI SWIFT DZIRE(2011-2015) VXI**

Chennai | 22816 km | Petrol | Manual | Silver Colour | 1st Owner

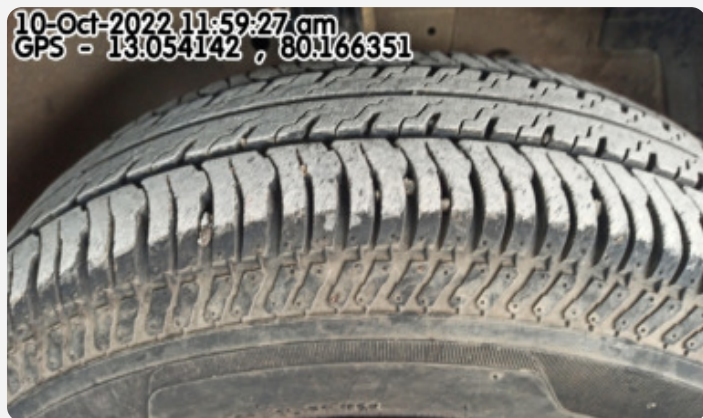
### Front Right Tyre

Condition : Good

Same Make/ Good & > 60% life

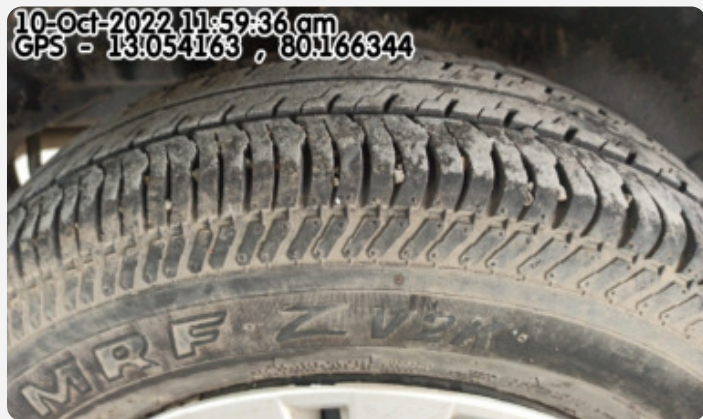
### Rear Right Tyre

Condition : Good

Same Make/ Good & > 60% life

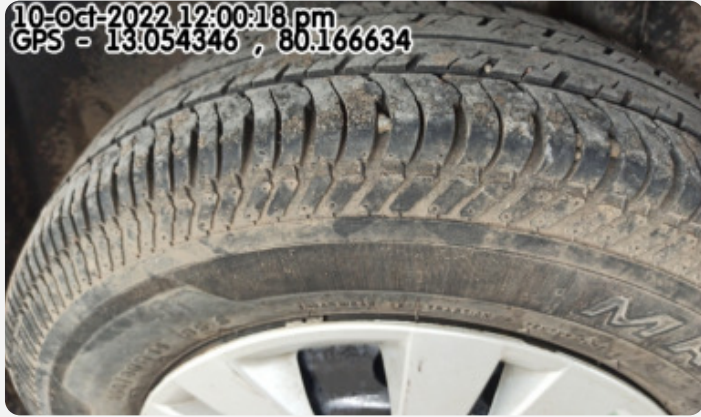
Rear Left Tyre

Condition : **Good**

Same Make/ Good & > 60% life

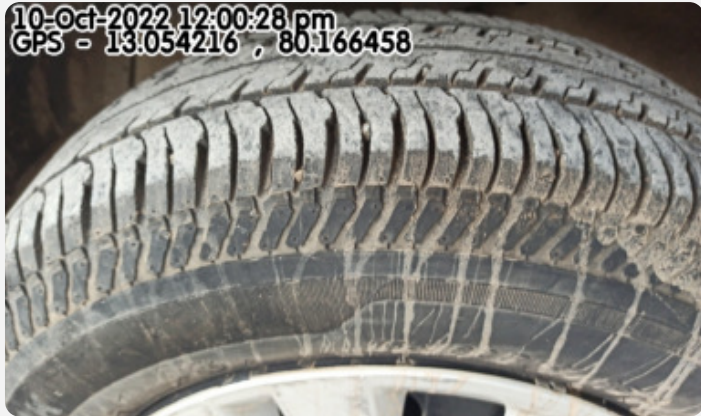
Front Left Tyre

Condition : **Good**

Same Make/ Good & > 60% life

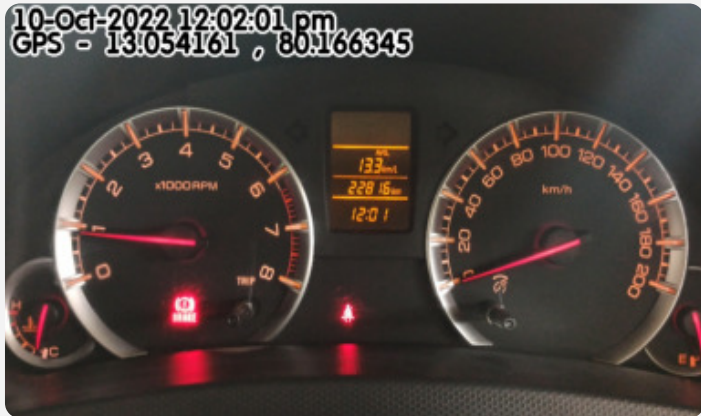
Odometer

**22816**
