Mahindra First Choice Wheels Certification Report

2015 CHEVROLET SAIL(2014-2017) 1.3 LS

Nagpur | 72334 km | Diesel | Manual | Black Colour | 1st Owner

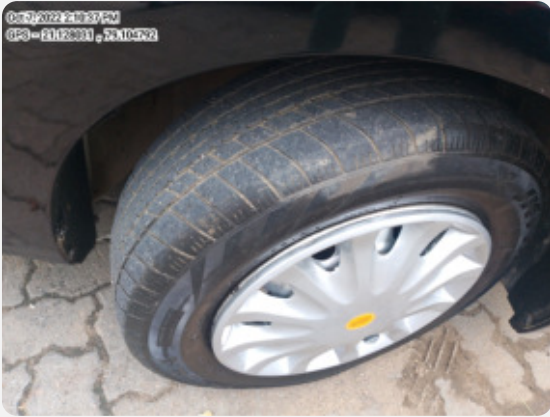
Front Right Tyre

Condition : **Good**

Same Make/ Good & > 60% life

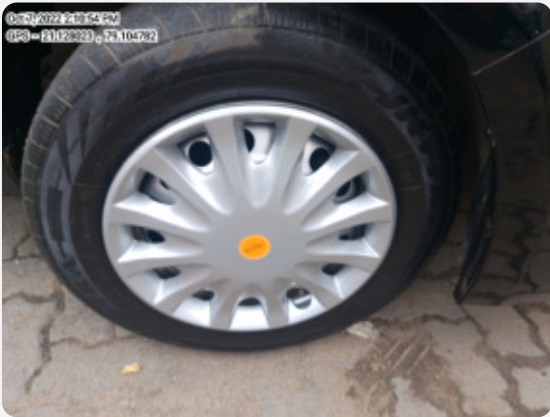
Rear Right Tyre

Condition : **Good**

Same Make/ Good & > 60% life

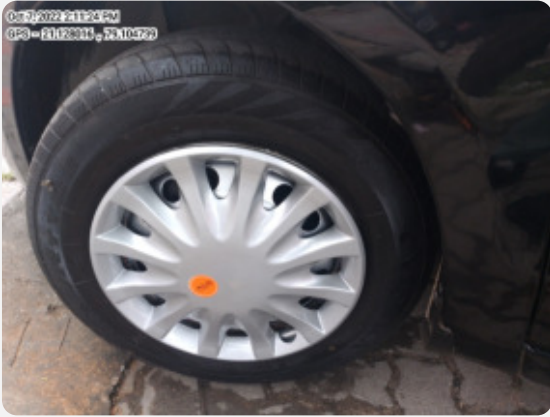
Rear Left Tyre

Condition : **Good**

Same Make/ Good & > 60% life

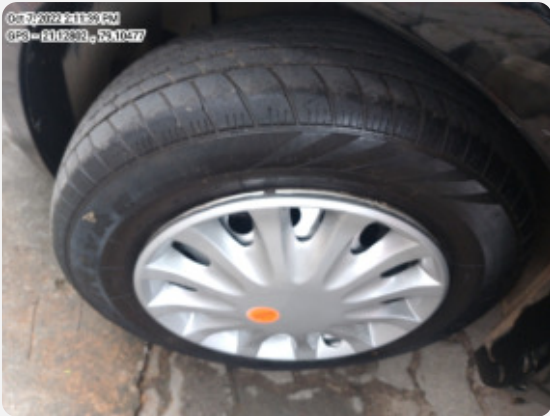
Front Left Tyre

Condition : **Good**

Same Make/ Good & > 60% life
