Mahindra First Choice Wheels Inspection Report

2012 NISSAN MICRA(2010-2013) XV DIESEL

Dehradun | 97076 km | Diesel | Manual | Red Colour | 1st Owner

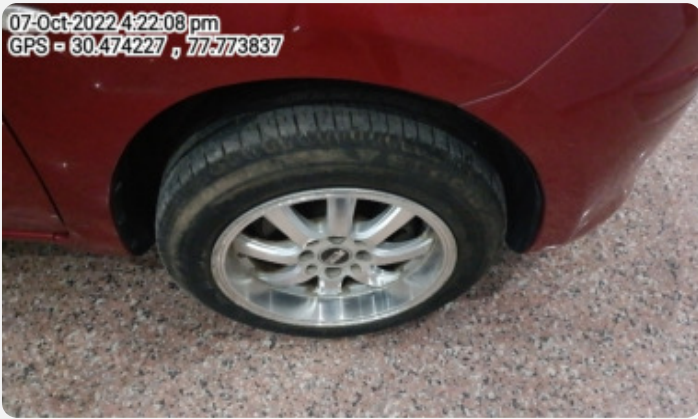
Front Right Tyre

Condition : Satisfactory

Same Make/ Good & > 40% life

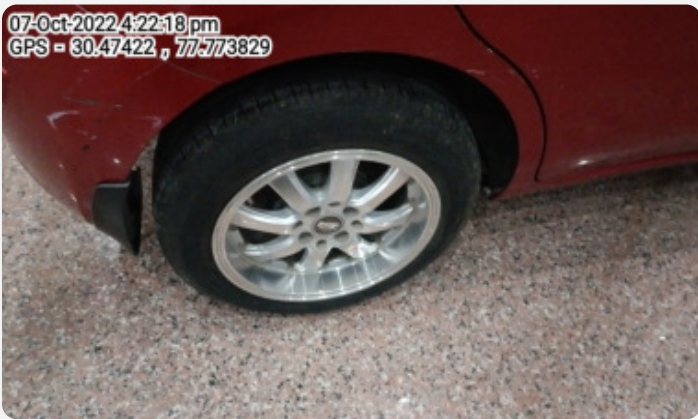
Rear Right Tyre

Condition : Satisfactory

Same Make/ Good & > 40% life

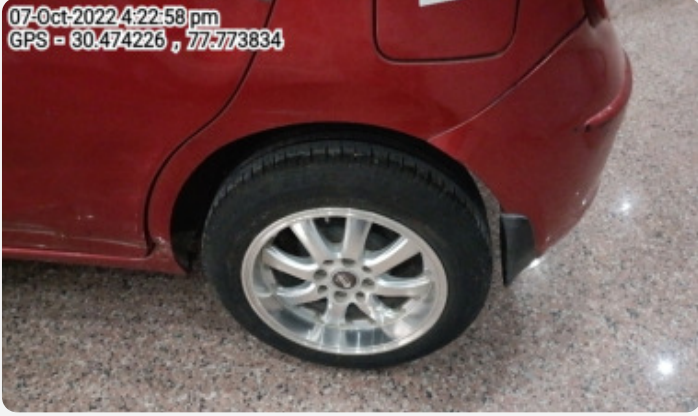
Rear Left Tyre

Condition : **Satisfactory**

Same Make/ Good & > 40% life

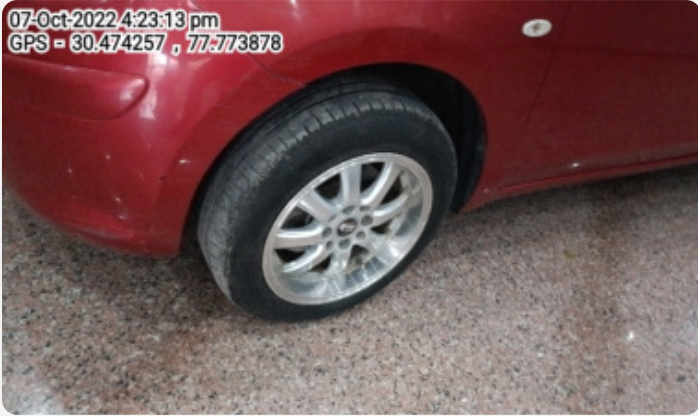
Front Left Tyre

Condition : **Satisfactory**

Same Make/ Good & > 40% life
