Mahindra First Choice Wheels Certification Report

**2017 TOYOTA FORTUNER(2016-2020) 2.8 4X2 AT**

Mumbai | 51031 km | Diesel | Automatic | White Colour | 1st Owner

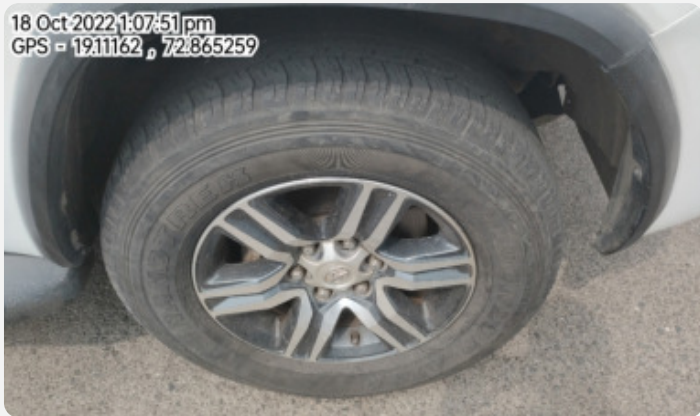
Front Right Tyre

Condition : Satisfactory

Same Make/ Good & > 40% life

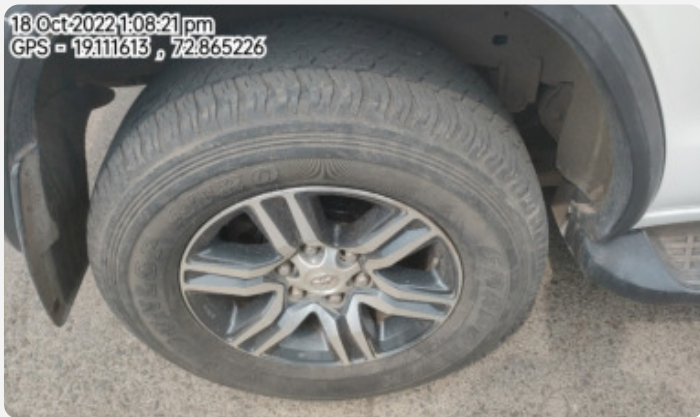
Rear Right Tyre

Condition : Satisfactory

Same Make/ Good & > 40% life

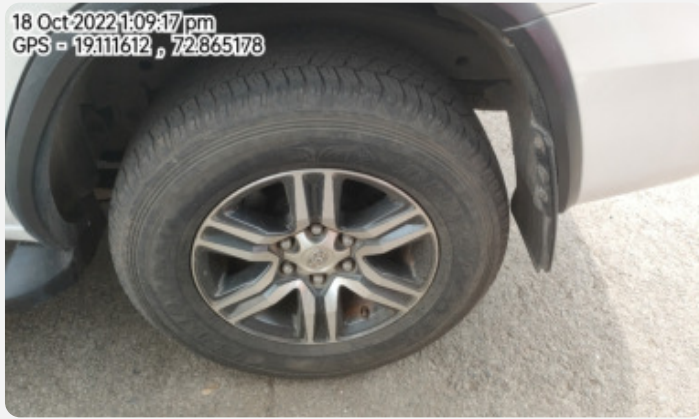
Rear Left Tyre

Condition : **Satisfactory**

Same Make/ Good & > 40% life

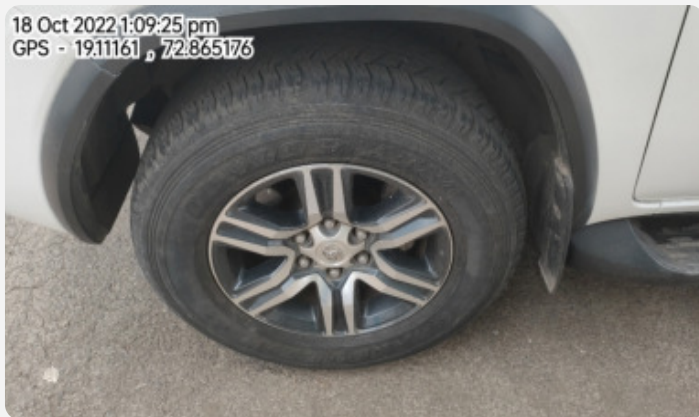
Front Left Tyre

Condition : **Satisfactory**

Same Make/ Good & > 40% life
