Mahindra First Choice Wheels Inspection Report

2009 MARUTI SUZUKI SWIFT DZIRE(2008-2010) VDI

Pathankot | 120819 km | Diesel | Manual | Silver Colour | 2nd Owner

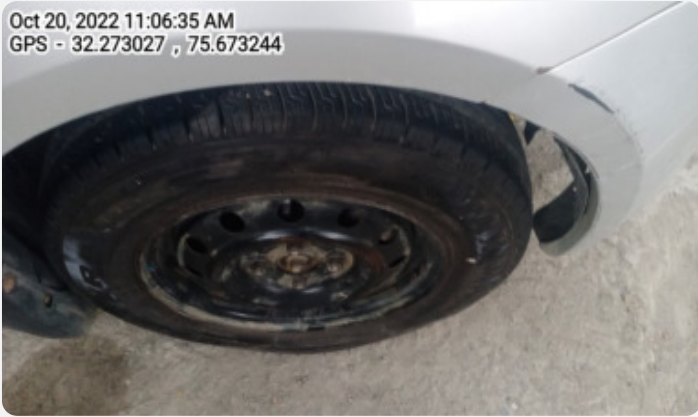
Front Right Tyre

Condition : **Good**

Same Make/ Good & > 60% life

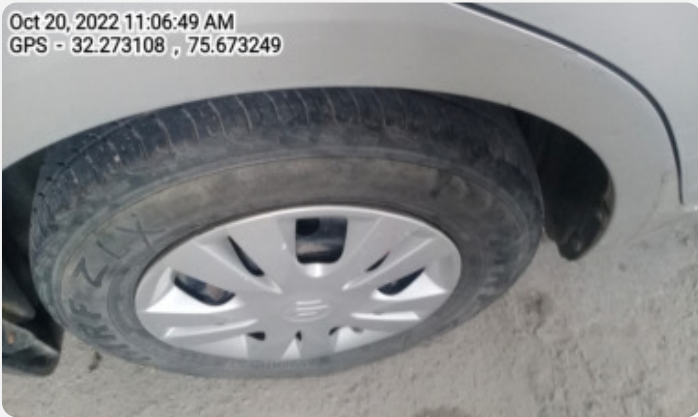
Rear Right Tyre

Condition : **Good**

Same Make/ Good & > 60% life

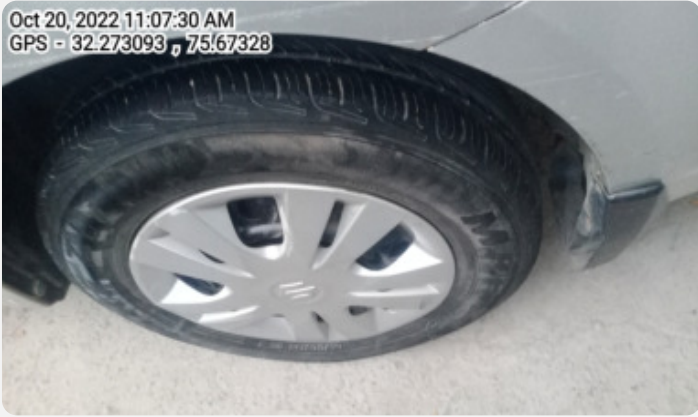
Rear Left Tyre

Condition : **Good**

Same Make/ Good & > 60% life

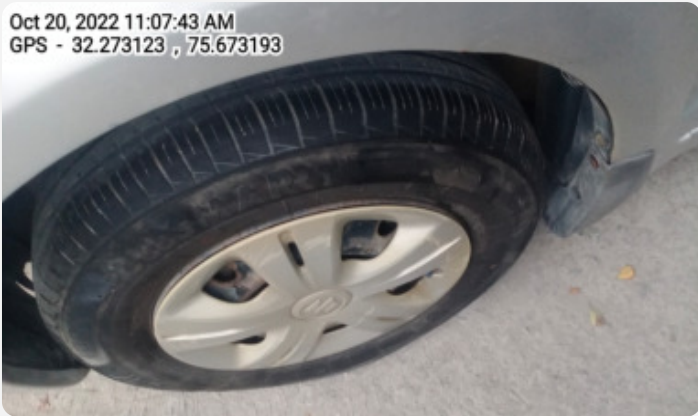
Front Left Tyre

Condition : **Good**

Same Make/ Good & > 60% life

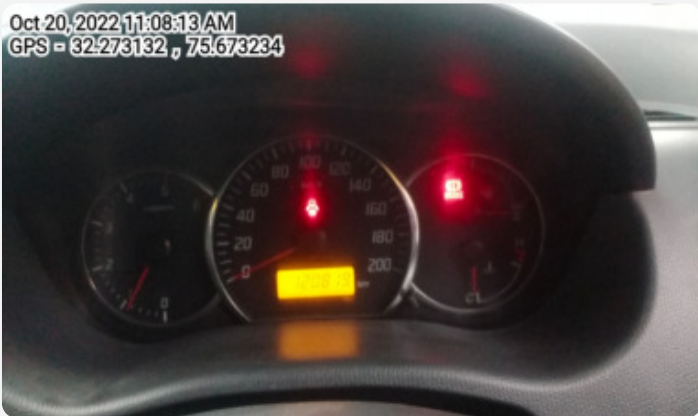
Odometer Reading(km)

120819
