Mahindra First Choice Wheels Inspection Report

2011 VOLKSWAGEN POLO(2010-2012) HIGHLINE 1.2L P

South Delhi | 69710 km | Petrol | Manual | Silver Colour | 1st Owner

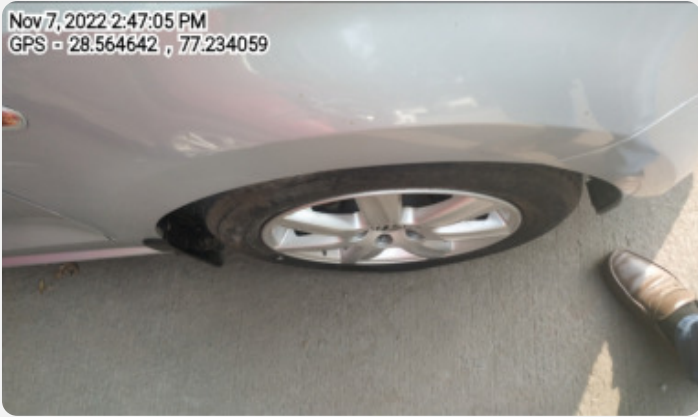
Front Right Tyre

Condition : Satisfactory

Same Make/ Good & > 40% life

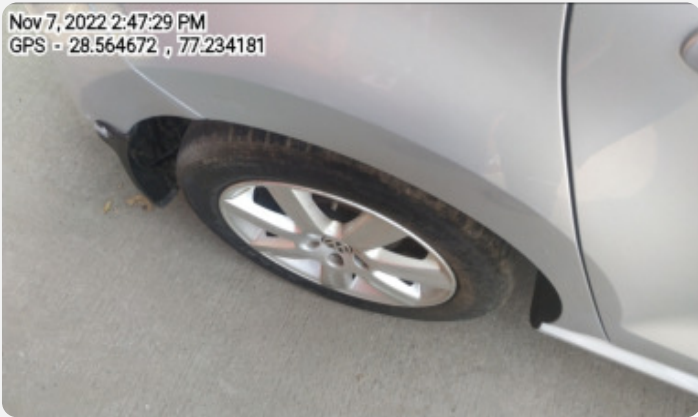
Rear Right Tyre

Condition : Satisfactory

Same Make/ Good & > 40% life

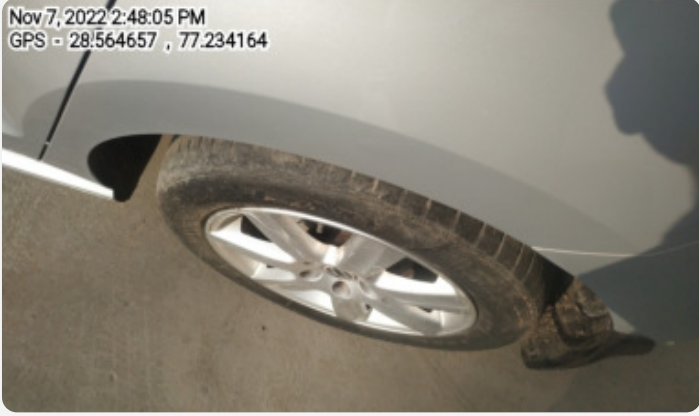
Rear Left Tyre

Condition : **Satisfactory**

Same Make/ Good & > 40% life

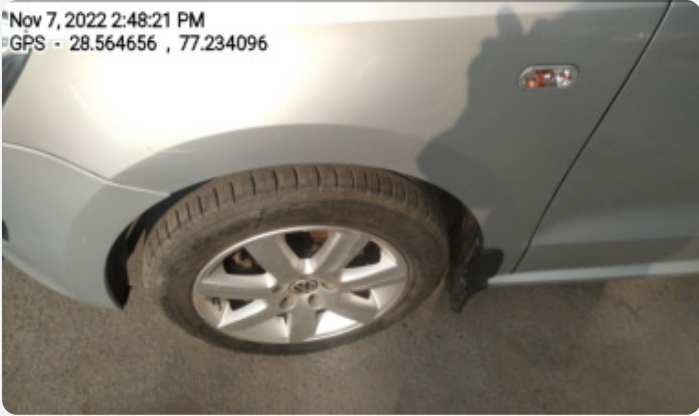
Front Left Tyre

Condition : **Satisfactory**

Same Make/ Good & > 40% life

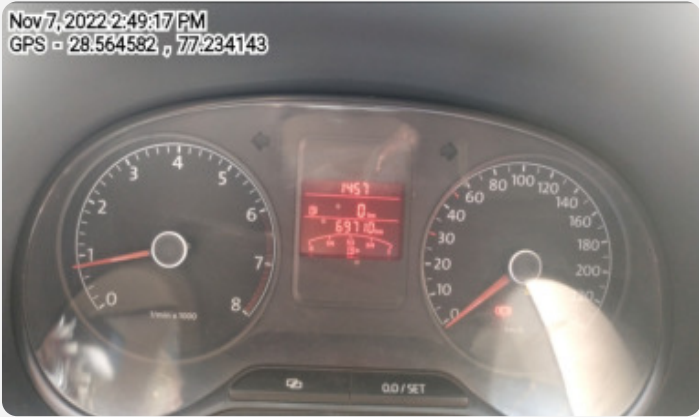
Odometer Reading(km)

69710
