Mahindra First Choice Wheels Inspection Report

2012 MITSUBISHI PAJERO SPORT(2012-2021) 2.5 MT

New Delhi | 128992 km | Diesel | Manual | White Colour | 1st Owner

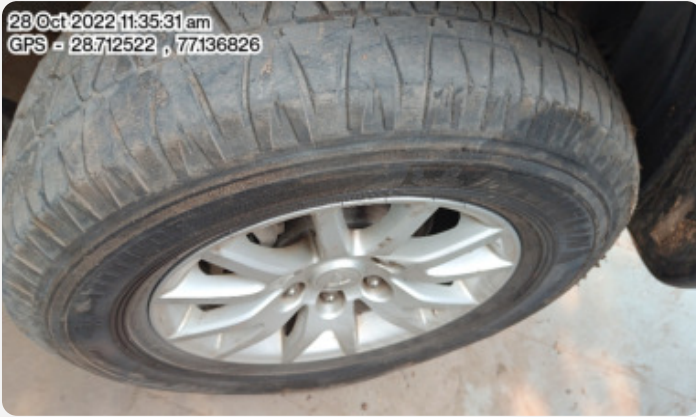
Front Right Tyre

Condition : Good

Same Make/ Good & > 60% life

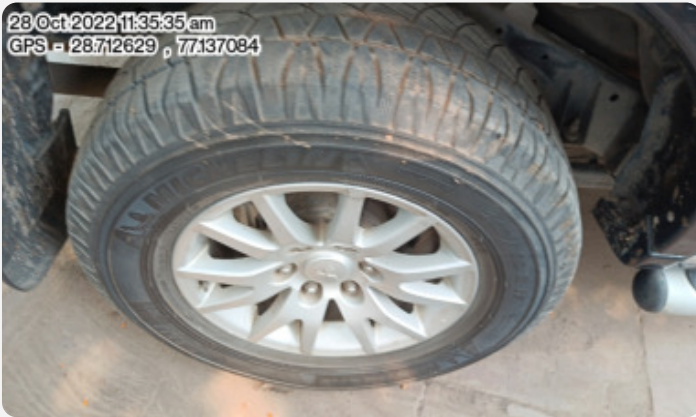
Rear Right Tyre

Condition : Good

Same Make/ Good & > 60% life

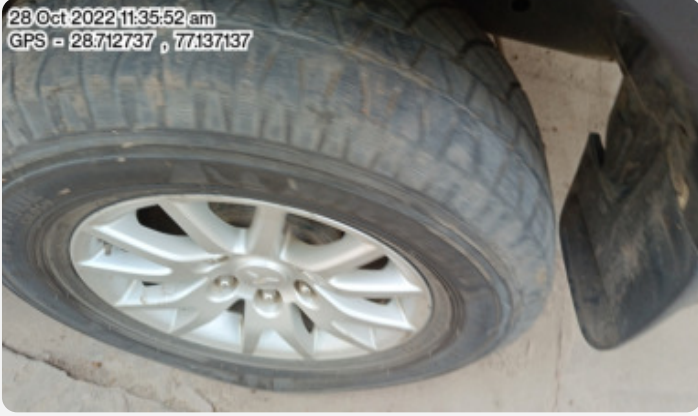
Rear Left Tyre

Condition : **Good**

Same Make/ Good & > 60% life

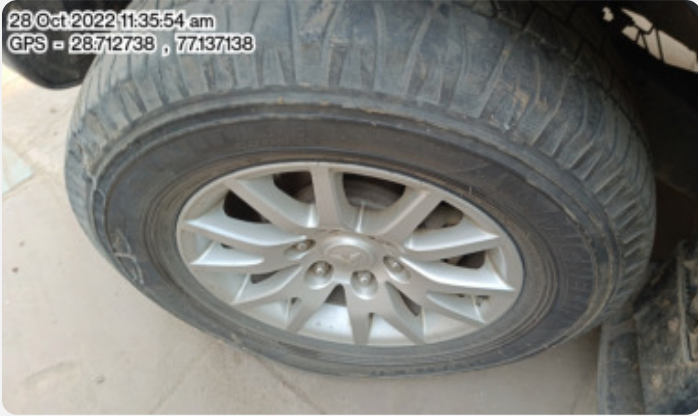
Front Left Tyre

Condition : **Good**

Same Make/ Good & > 60% life
