Mahindra First Choice Wheels Inspection Report

2014 MARUTI SUZUKI ERTIGA(2012-2015) VDI

Moradabad | 64866 km | Diesel | Manual | White Colour | 1st Owner

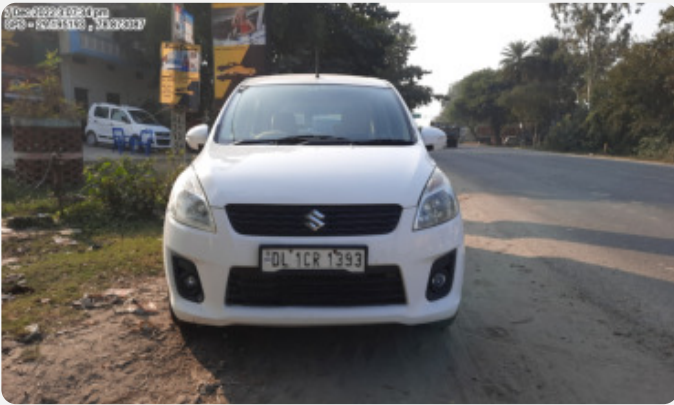
Front Side

Condition : **Bad**
Alignment Issue

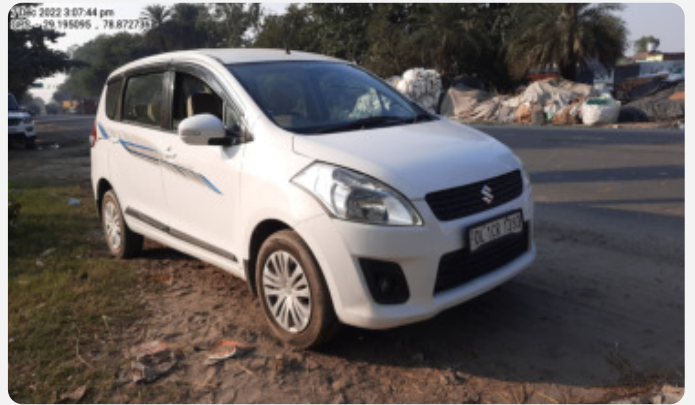
Front Right Side

Condition : **Bad**
Dent with Paint Damage

Condition : **Bad**
Dents With Paint Damage

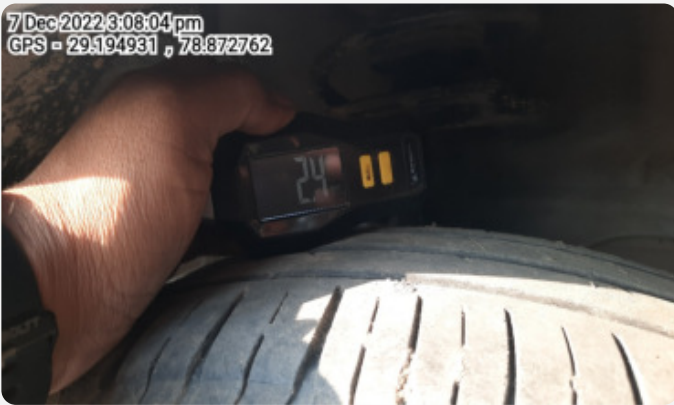
Front Right Tyre

Condition : **Bad**

Less than 20%

Condition : **Satisfactory**

Rust

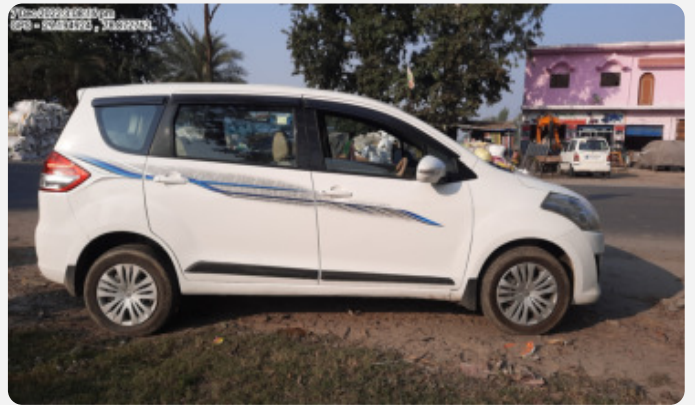
Right Side

Condition : **Bad**
Dents With Paint Damage

Condition : **Bad**

Spot Welding Removed

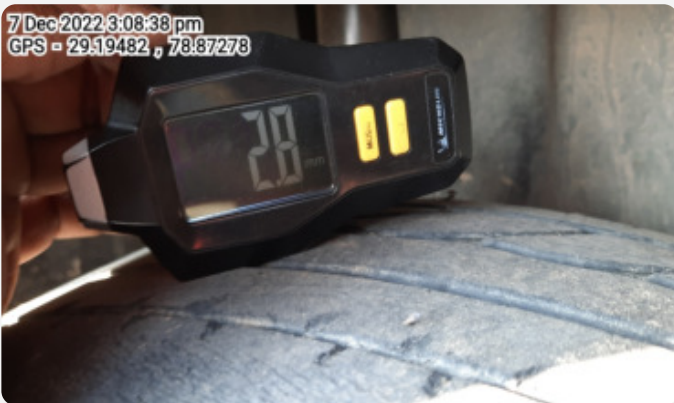
Rear Right Tyre

Condition : **Bad**

Less than 20%

Condition : **Satisfactory**

Rust

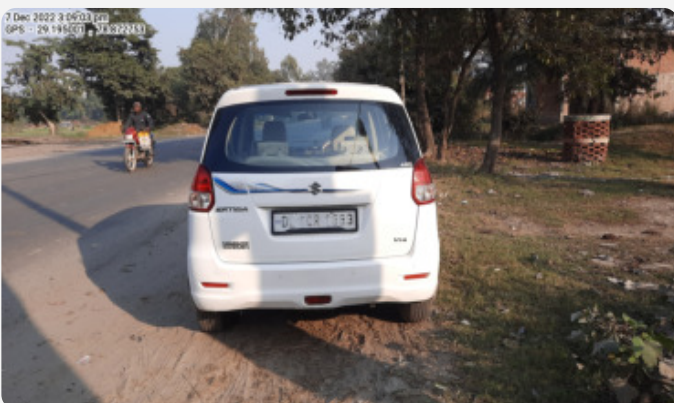
Back Side

Condition : **Bad**

Repaired/Screw Fitting

Alignment Issue

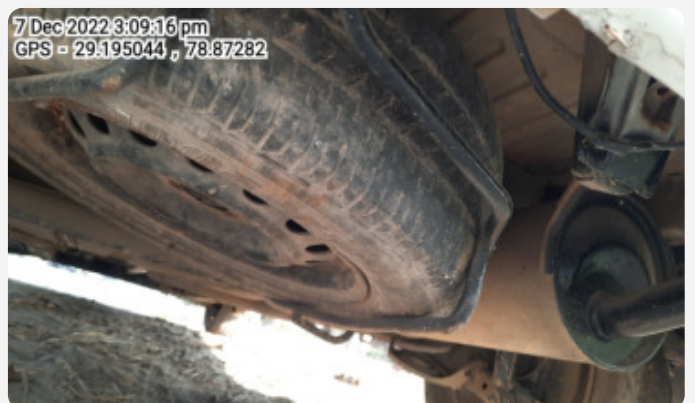
Spare Tyre

Condition : **Bad**

Different Make/ Cut Marks/
Bulge /< 30% life

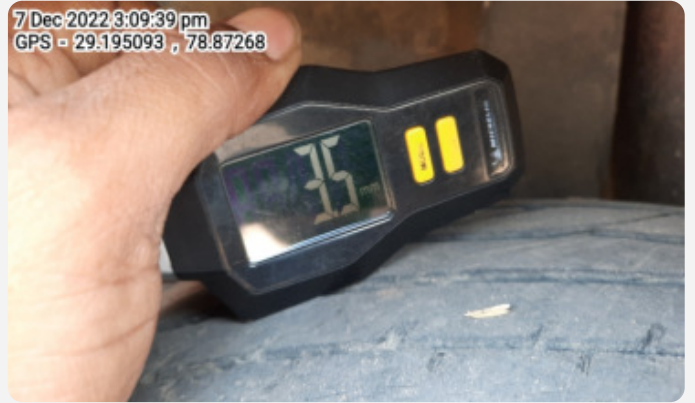
Rear Left Tyre

Condition : **Bad**

Less than 20%

Condition : **Satisfactory**

Rust

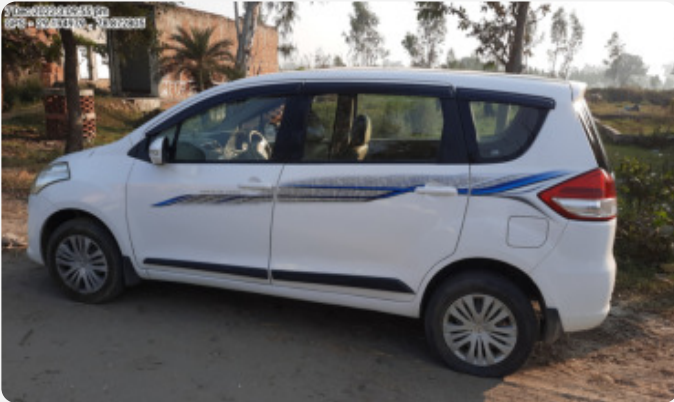
Left Side

Condition : **Bad**

Deep/long Scratches-2 & Above

Condition : **Good**

Visible Repaint

Spot Welding Removed

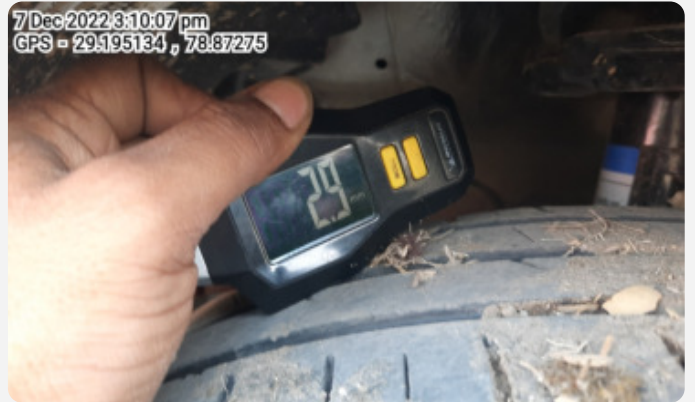
Front Left Tyre

Condition : **Bad**

Less than 20%

Condition : **Satisfactory**

Rust

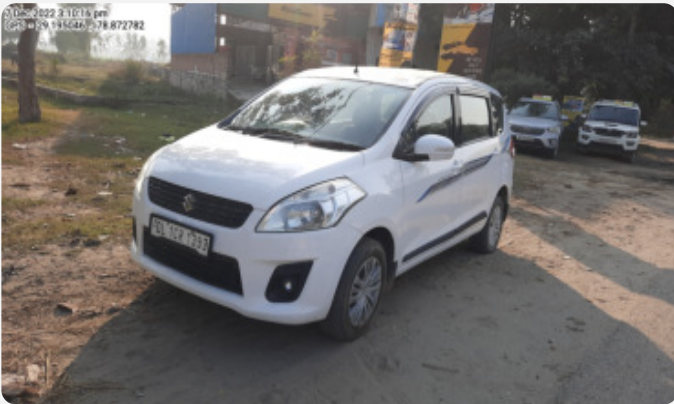
Front Left Side

Condition : **Bad**

Dent with Paint Damage

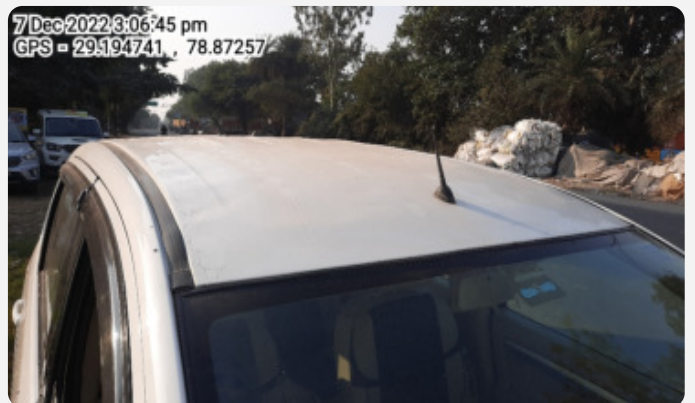
Top Side

Condition : **Satisfactory**

Dents without paint damage-3
