### Mahindra First Choice Wheels Certification Report

## 2016 MARUTI SUZUKI CIAZ(2014-2017) ZDI PLUS

Dadra & Nagar Haveli | 67644 km | Diesel | Manual | White Colour | 2nd Owner

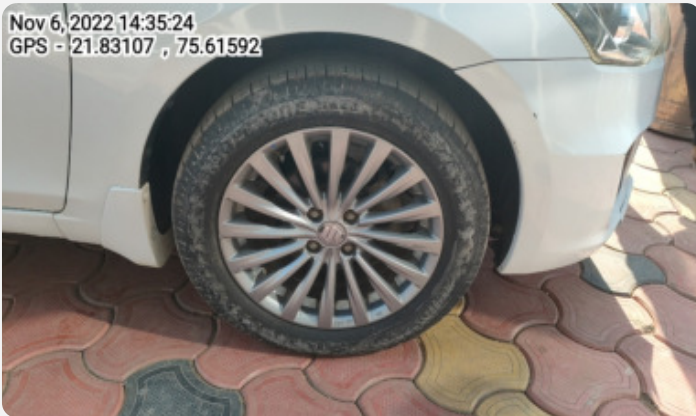
### Front Right Tyre

Condition : **Good**

Same Make/ Good & > 60% life

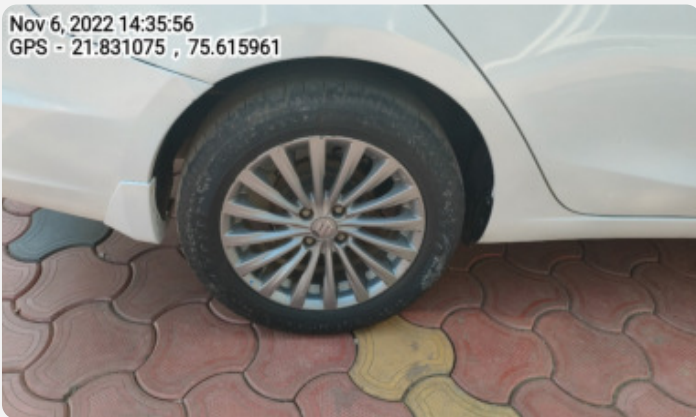
### Rear Right Tyre

Condition : **Good**

Same Make/ Good & > 60% life

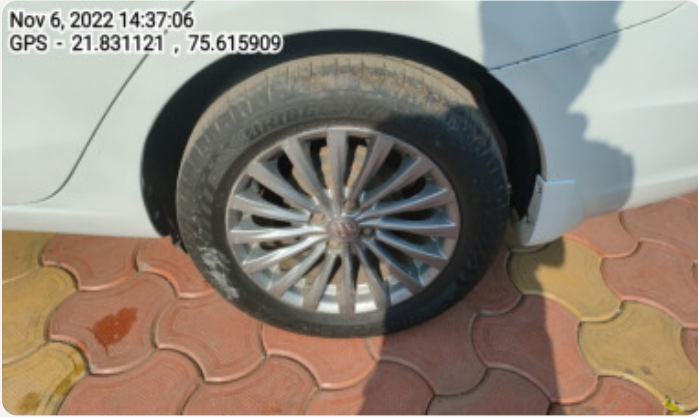
**Rear Left Tyre**

Condition : **Good**

Same Make/ Good & > 60% life

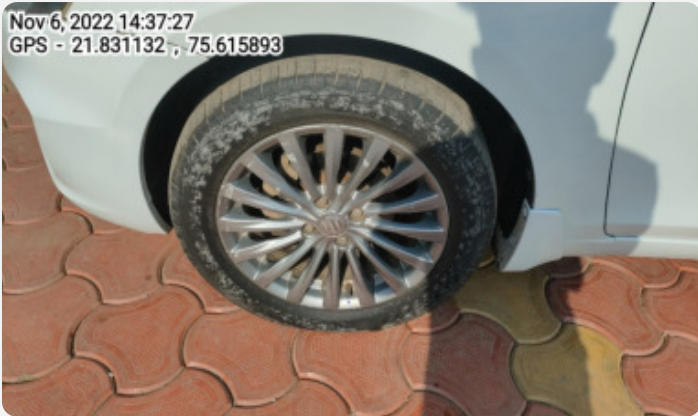
**Front Left Tyre**

Condition : **Excellent**

Same Make/ Good & > 80% life

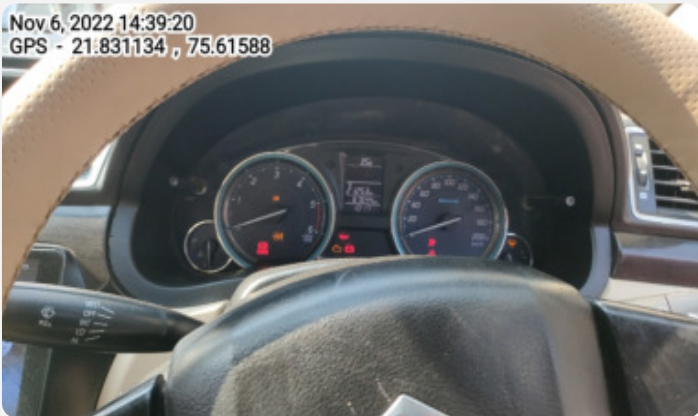
**Odometer**

**67644**

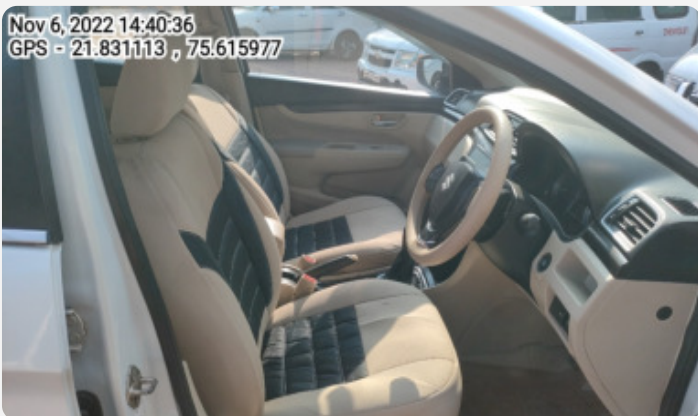
**Front 2 seats**

Condition : **Excellent**

Seat cover is in good condition
