Mahindra First Choice Wheels Inspection Report

2010 HYUNDAI SONATA TRANSFORM(2009-2011) 2.0 CRDI AT

Ghaziabad | 72566 km | Diesel | Automatic | Black Colour | 1st Owner

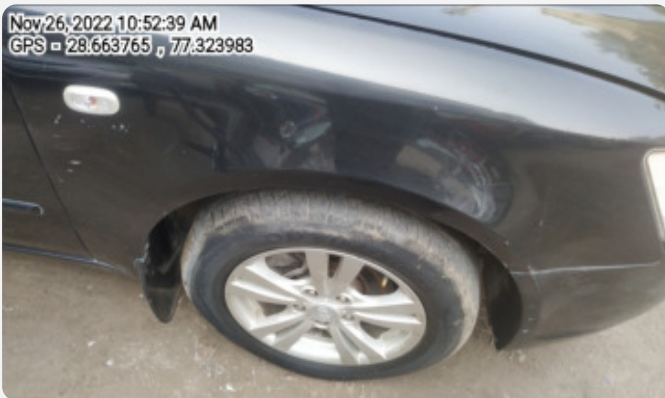
Front Right Tyre

Front right tyre

Condition : **Bad**

Less than 20%

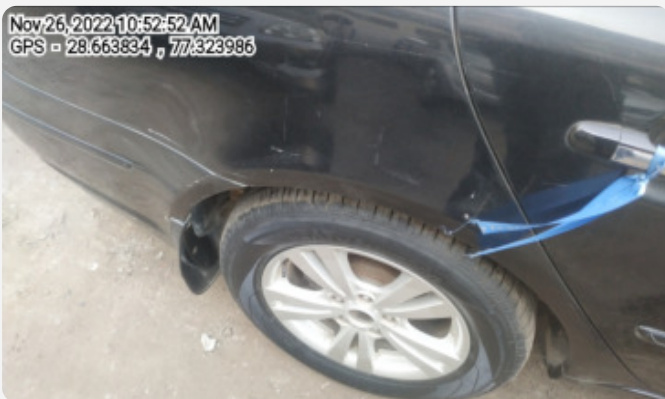
Rear Right Tyre

Rear right tyre

Condition : **Bad**

Less than 20%

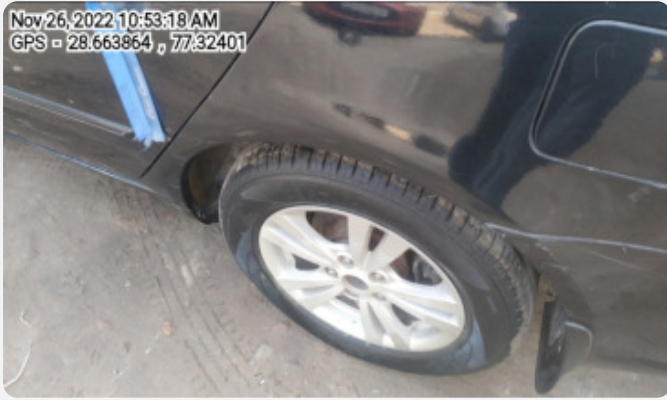
Rear Left Tyre

Rear Left tyre

Condition : **Bad**

Less than 20%

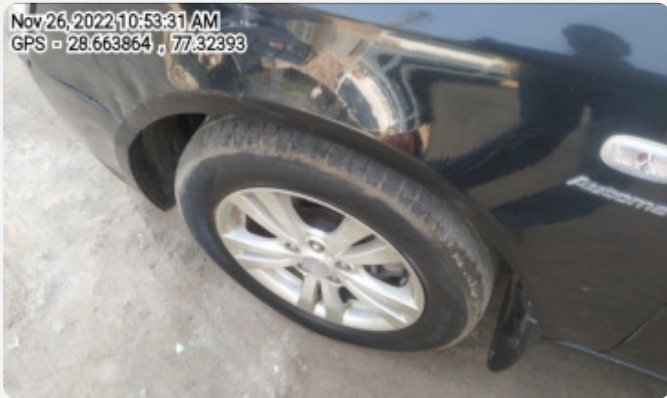
Front Left Tyre

Front Left tyre

Condition : **Bad**

Less than 20%
