Mahindra First Choice Wheels Certification Report

**2015 MARUTI SUZUKI BALENO(2015-2019) ZETA 1.2**

Gurgaon | 70171 km | Petrol | Manual | White Colour | 2nd Owner

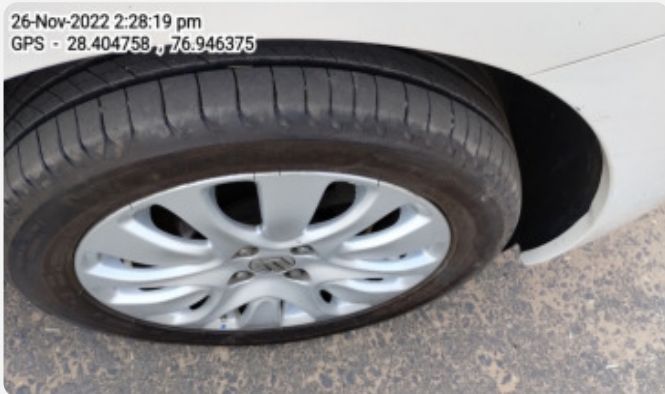
Front Right Tyre

Front right tyre

Condition : **Excellent**

Above 80% life

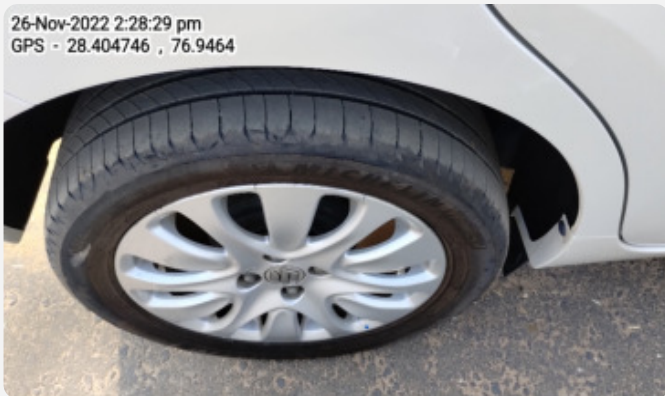
Rear Right Tyre

Rear right tyre

Condition : **Excellent**

Above 80% life

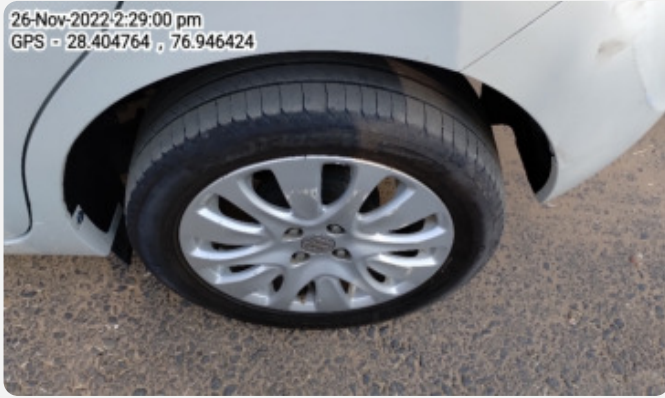
Rear Left Tyre

Rear Left tyre

Condition : **Excellent**

Above 80% life

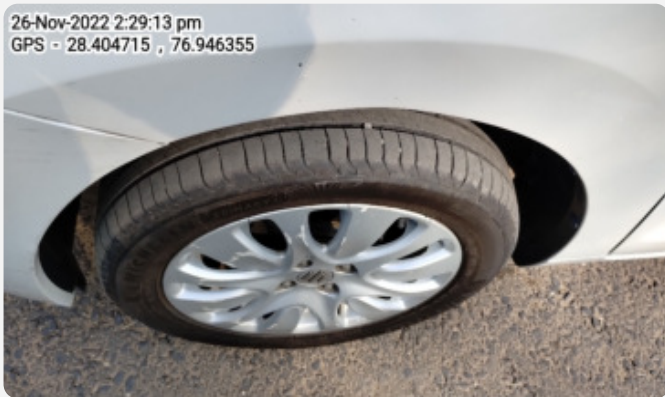
Front Left Tyre

Front Left tyre

Condition : **Excellent**

Above 80% life

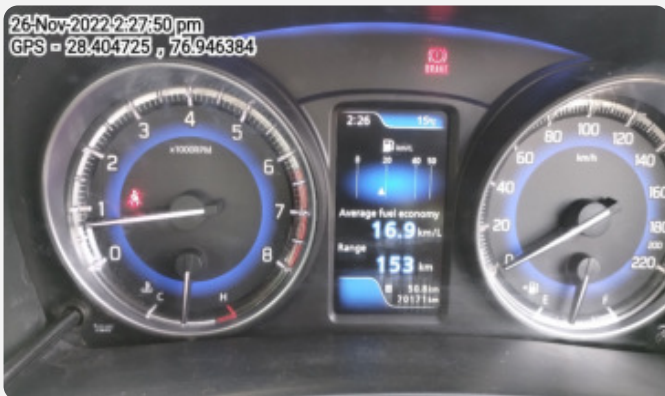
Odometer

**Instrument panel gauges:
Odometer**

Condition : **Excellent**

Good Condition
