Mahindra First Choice Wheels Certification Report

**2017 FORD ECOSPORT(2015-2017) TITANIUM 1.5L TDCI**

Chaziabad | 73966 km | Diesel | Manual | White Colour | 1st Owner

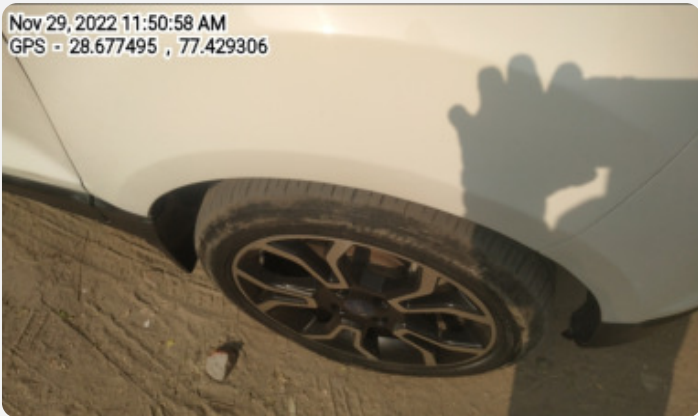
Front Right Tyre

Front right tyre

Condition : **Good**

60%-80%

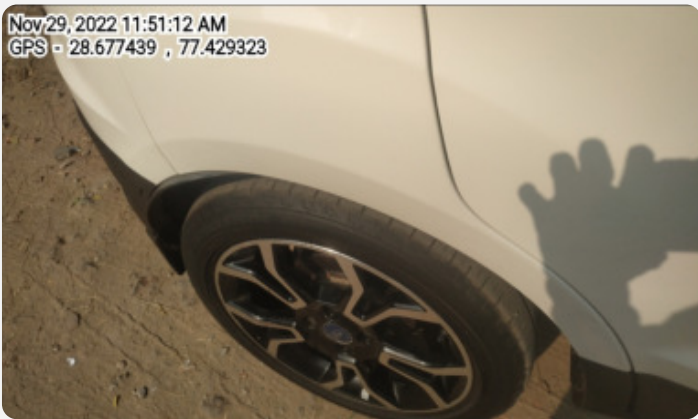
Rear Right Tyre

Rear right tyre

Condition : **Good**

60%-80%

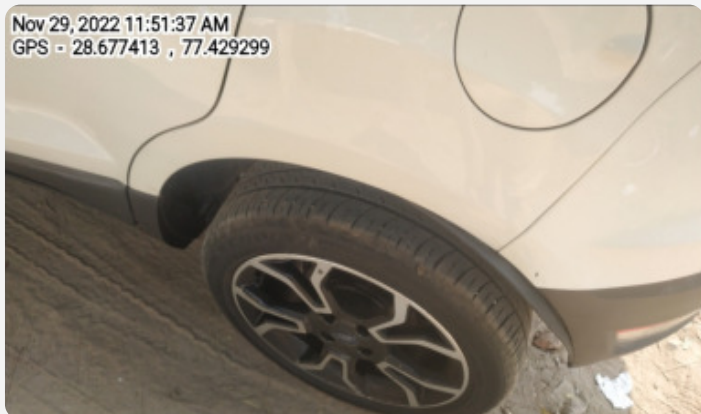
Rear Left Tyre

Rear Left tyre

Condition : **Good**

60%-80%

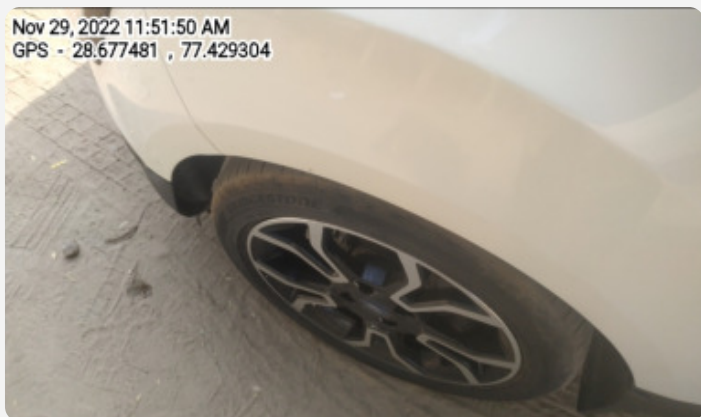
Front Left Tyre

Front Left tyre

Condition : **Good**

60%-80%

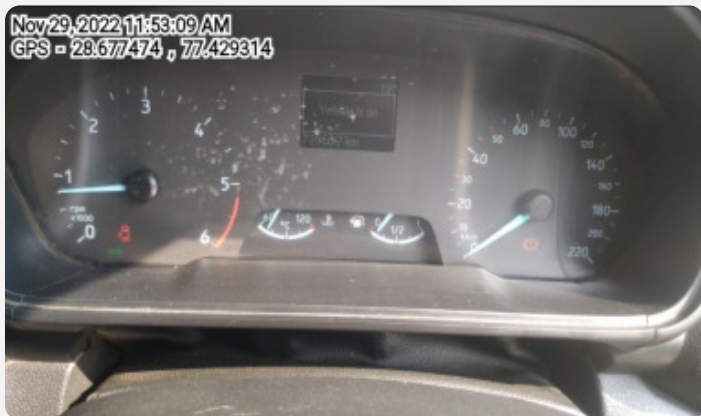
Instrument panel gauges: Odometer

Condition : **Excellent**

Good Condition
