Mahindra First Choice Wheels Certification Report

2017 TATA TIAGO(2016-2019) REVOTRON XZ

Kozhikode | 72408 km | Petrol | Manual | Others Colour | 1st Owner

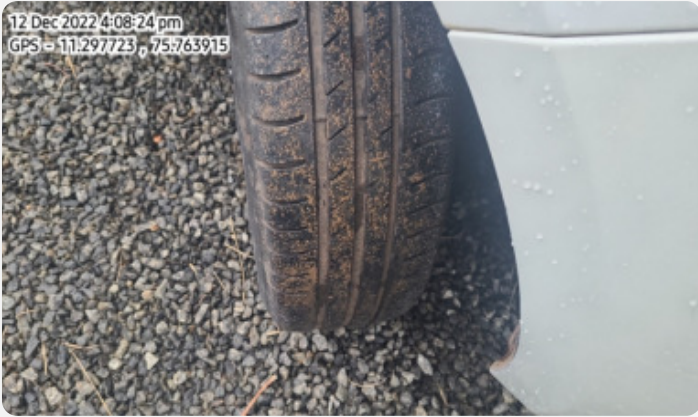
Front Right Tyre

Condition : **Satisfactory**

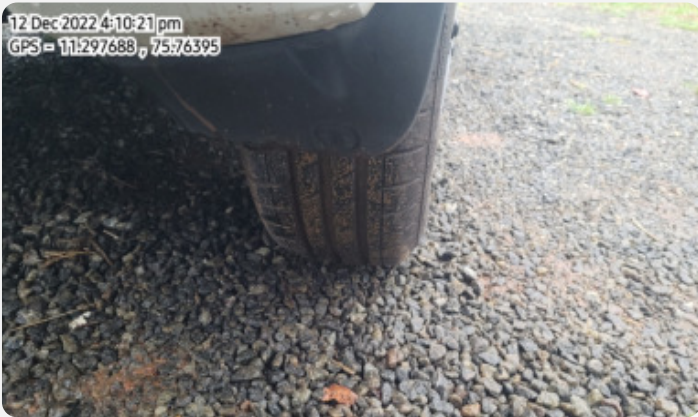
Rear Right Tyre

Condition : **Satisfactory**

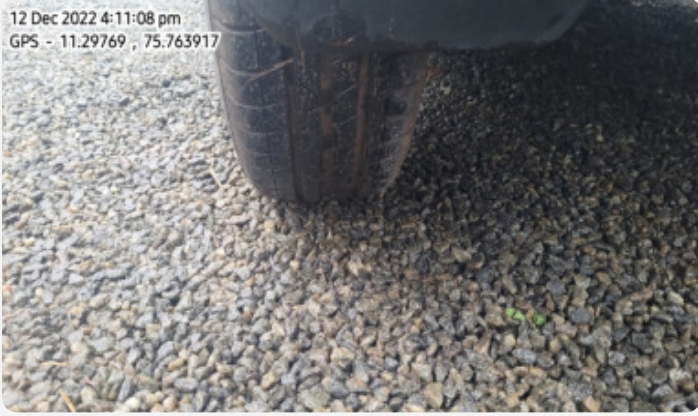
Rear Left Tyre

Condition : **Satisfactory**

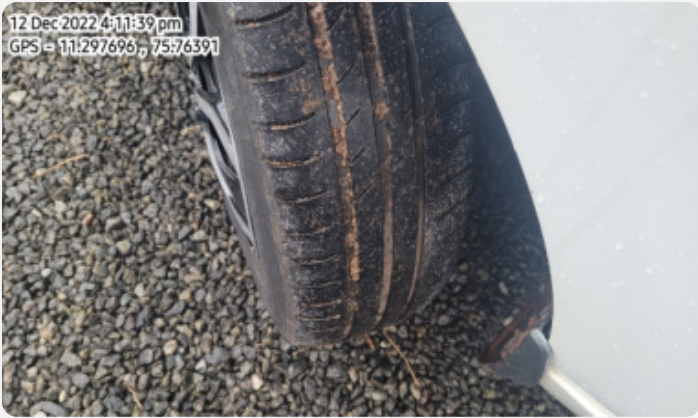
Front Left Tyre

Condition : **Satisfactory**

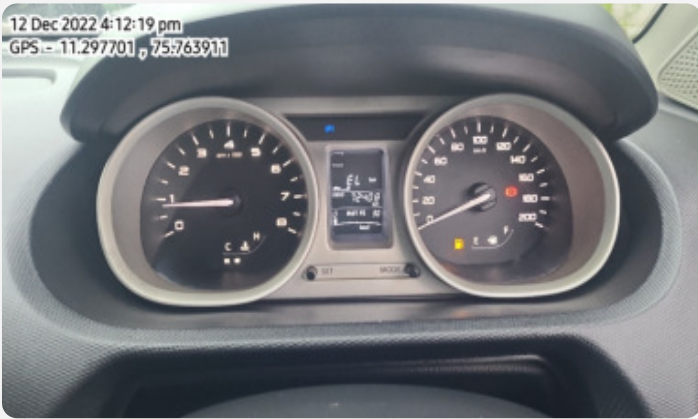
Odometer

Condition : **Excellent**
