## Mahindra First Choice Wheels Certification Report

**2017 MARUTI SUZUKI ALTO 800(2016-2019) LXI**

Moradabad | 7652 km | Petrol | Manual | Silver Colour | 1st Owner

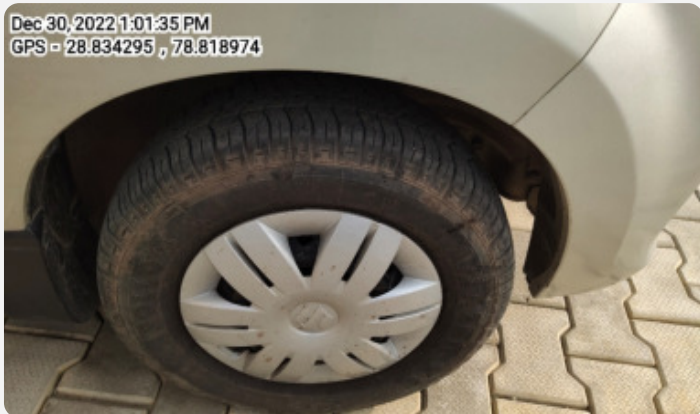
### Front Right Tyre

**Front right tyre**

Condition : **Satisfactory**

40%-60%

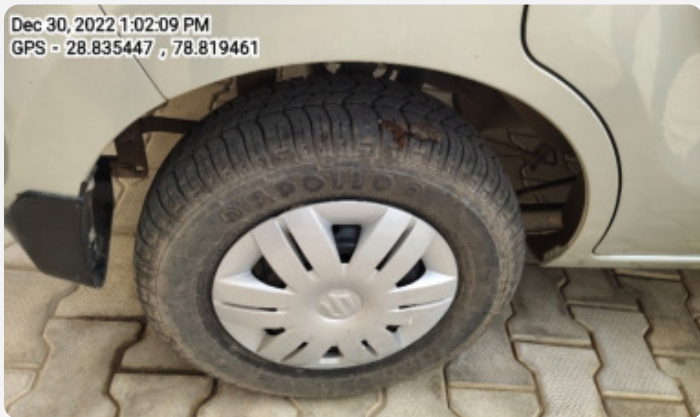
### Rear Right Tyre

**Rear right tyre**

Condition : **Satisfactory**

40%-60%

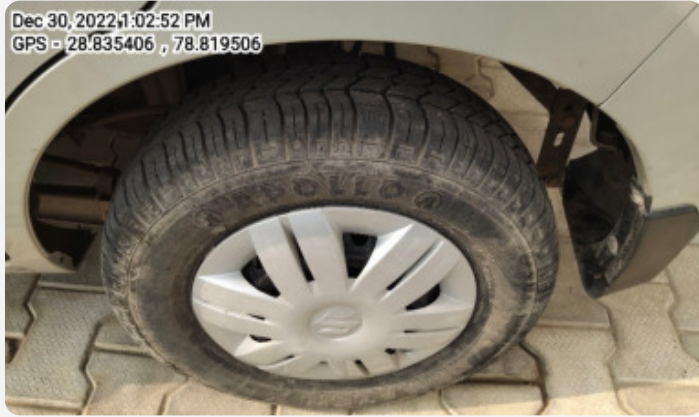
#### Rear Left Tyre

**Rear Left tyre**

Condition : **Satisfactory**

40%-60%

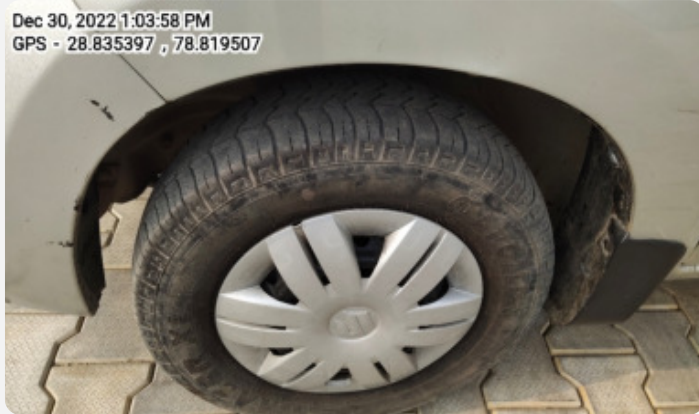
#### Front Left Tyre

**Front Left tyre**

Condition : **Satisfactory**

40%-60%
