Mahindra First Choice Wheels Inspection Report

2011 HYUNDAI EON(2011-2019) MAGNA

Faridabad | 72306 km | Petrol | Manual | Silver Colour | 2nd Owner

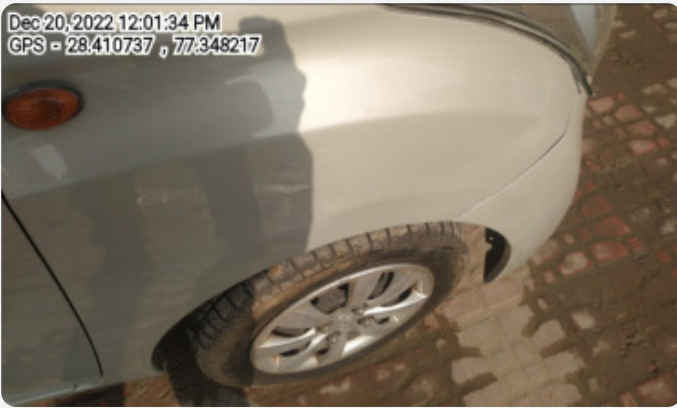
Front Right Tyre

Front right tyre

Condition : **Satisfactory**

25-40%

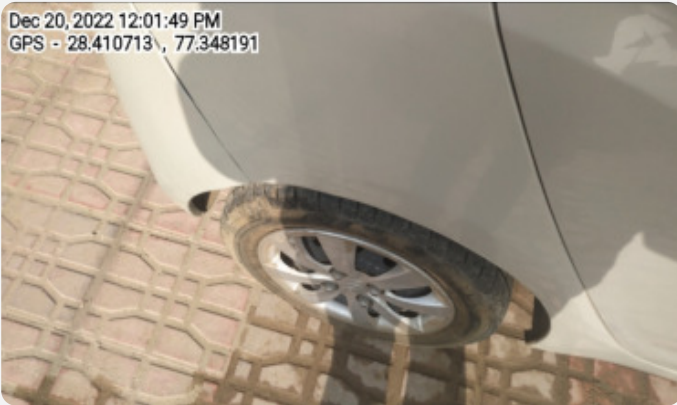
Rear Right Tyre

Rear right tyre

Condition : **Satisfactory**

25-40%

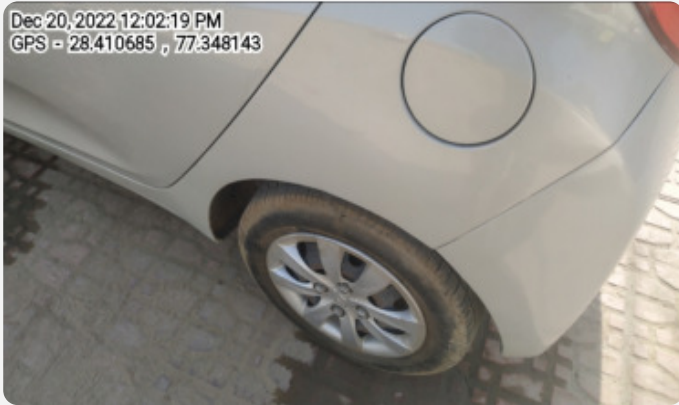
Rear Left Tyre

Rear Left tyre

Condition : **Satisfactory**

25-40%

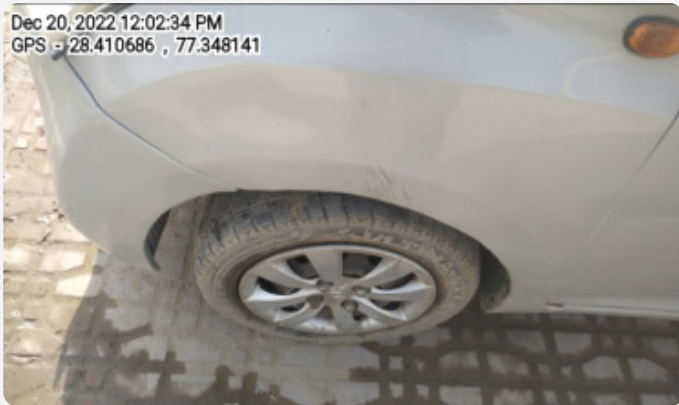
Front Left Tyre

Front Left tyre

Condition : **Satisfactory**

25-40%
