Mahindra First Choice Wheels Certification Report

2016 TOYOTA ETIOS(2014-2016) V

Kollam | 27630 km | Petrol | Manual | Silver Colour | 2nd Owner

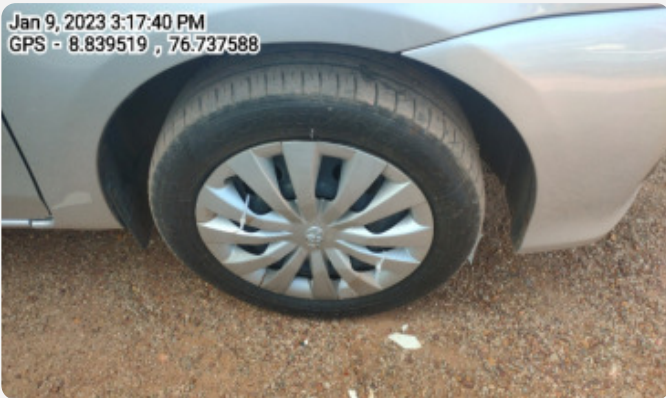
Front Right Tyre

Front right tyre

Condition : **Good**

60%-80%

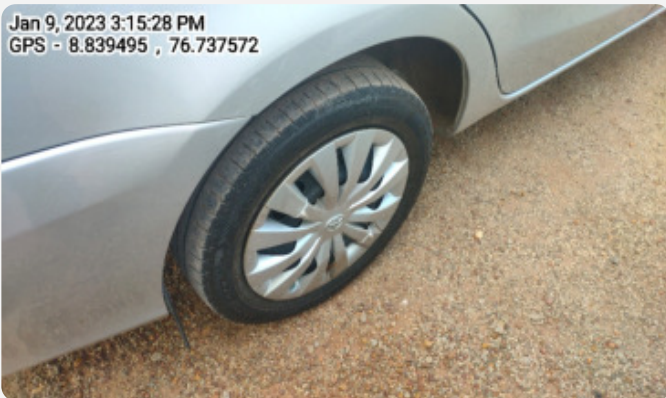
Rear Right Tyre

Rear right tyre

Condition : **Good**

60%-80%

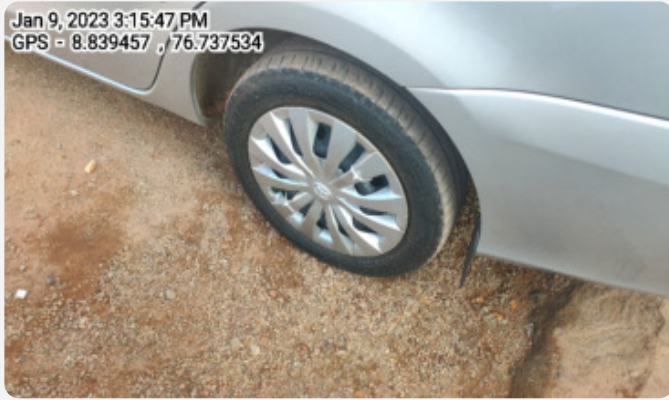
Rear Left Tyre

Rear Left tyre

Condition : **Good**

60%-80%

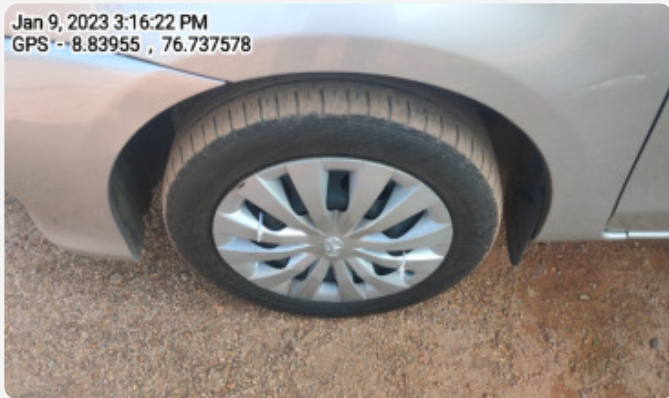
Front Left Tyre

Front Left tyre

Condition : **Good**

60%-80%

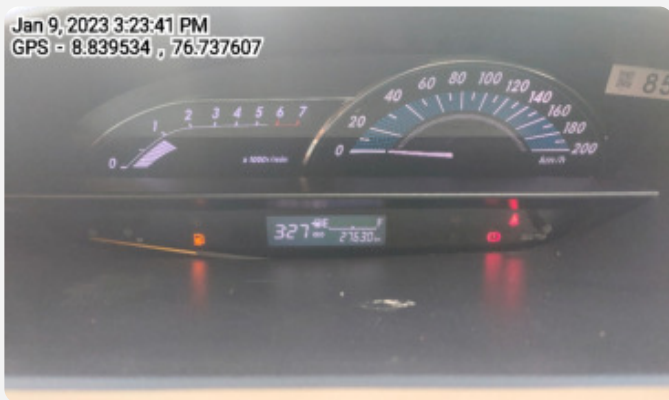
Odometer

**Instrument panel gauges:
Odometer**

Condition : **Excellent**
Good Condition
