Mahindra First Choice Wheels Certification Report

2018 MARUTI SUZUKI VITARA BREZZA(2016-2020) ZDI

Panchkula | 95380 km | Diesel | Manual | Silver Colour | 2nd Owner

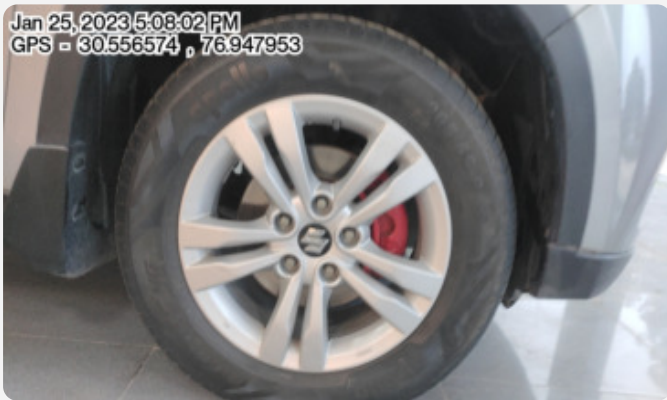
Front Right Tyre

Front right tyre

Condition : **Satisfactory**

25-40%

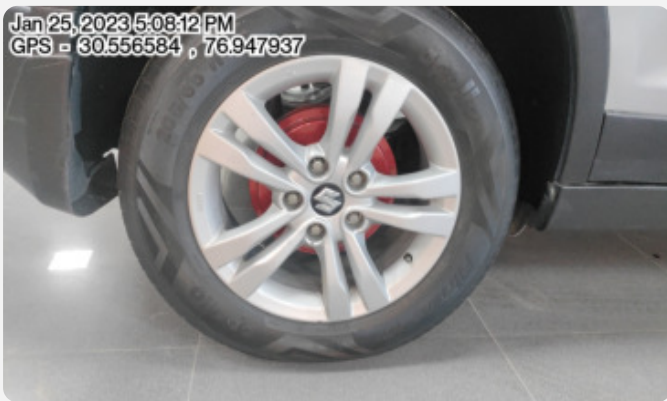
Rear Right Tyre

Rear right tyre

Condition : **Satisfactory**

25-40%

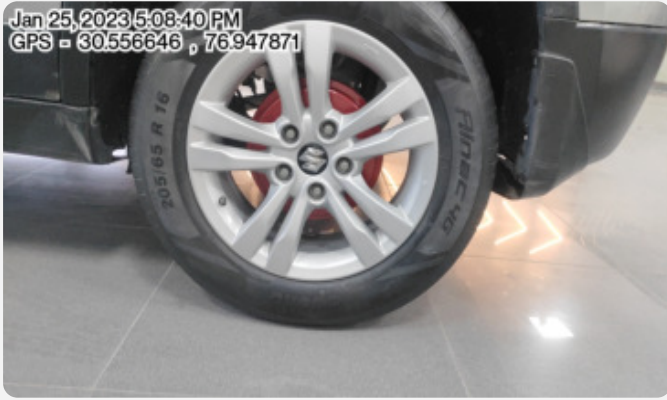
Rear Left Tyre

Rear Left tyre

Condition : **Satisfactory**

25-40%

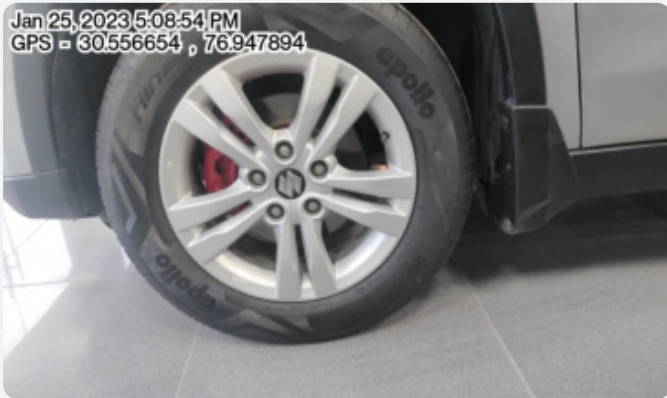
Front Left Tyre

Front Left tyre

Condition : **Satisfactory**

25-40%

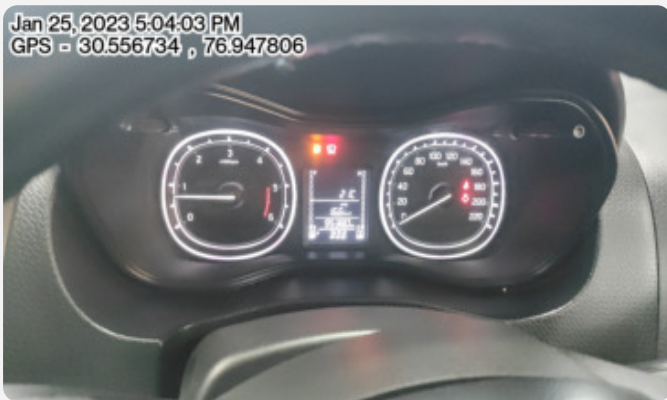
Odometer

**Instrument panel gauges:
Odometer**

Condition : **Excellent**

Good Condition
