Mahindra First Choice Wheels Inspection Report

2010 CHEVROLET TAVERA(2005-2012) LT LI 9 STR BS III

East Midnapore | 247498 km | Diesel | Manual | Gold Colour | 1st Owner

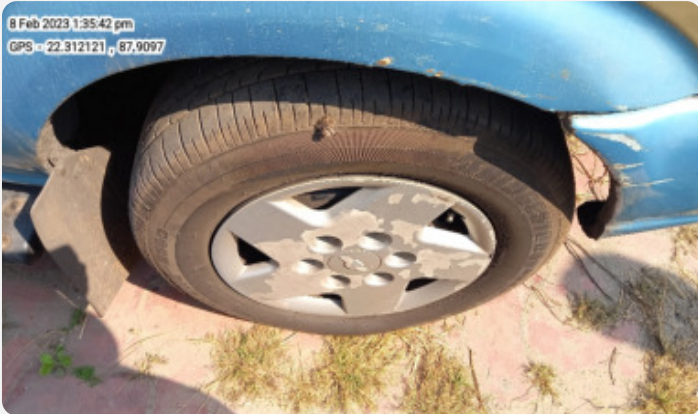
Front Right Tyre

Front right tyre

Condition : **Good**
60%-80%

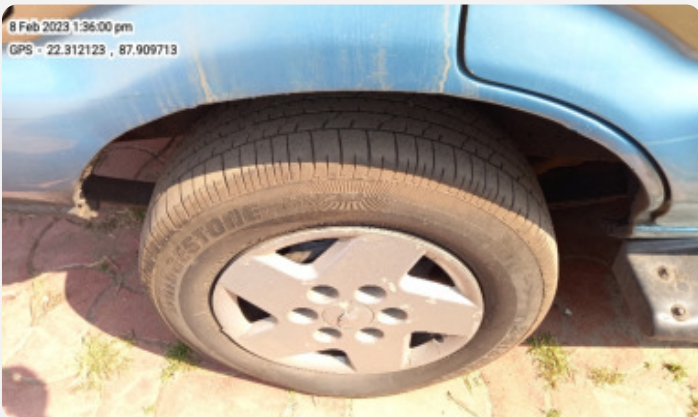
Rear Right Tyre

Rear right tyre

Condition : **Good**
60%-80%

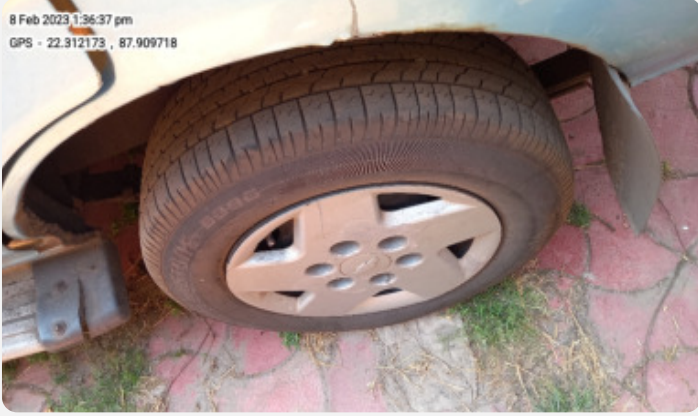
Rear Left Tyre

Rear Left tyre

Condition : **Good**

60%-80%

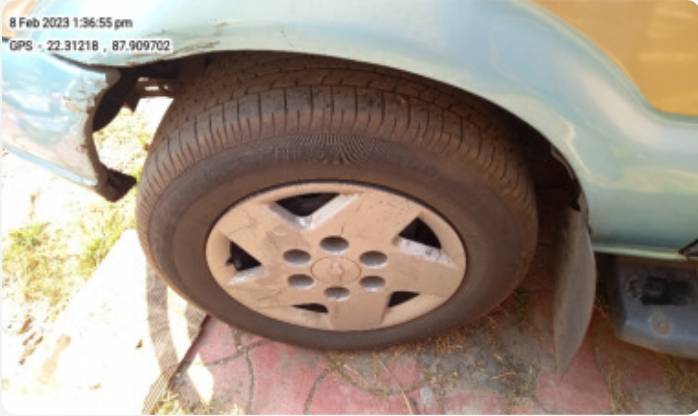
Front Left Tyre

Front Left tyre

Condition : **Good**

60%-80%

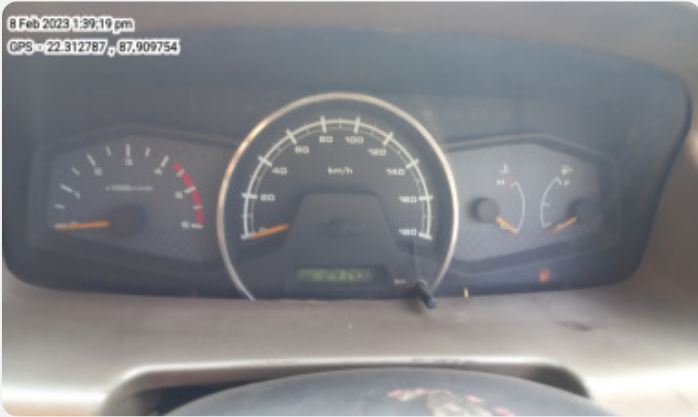
Odometer Reading(km)

247498

**Instrument panel gauges:
Odometer**

Condition : **Excellent**
Good Condition
