Mahindra First Choice Wheels Certification Report

2015 DATSUN GO PLUS(2014-2018) T

Kannur | 55615 km | Petrol | Manual | Grey Colour | 1st Owner

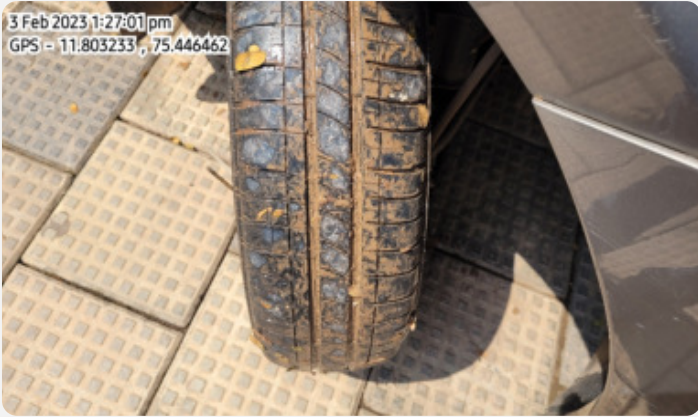
### Front Right Tyre

**Front right tyre**

Condition : **Satisfactory**

40%-60%

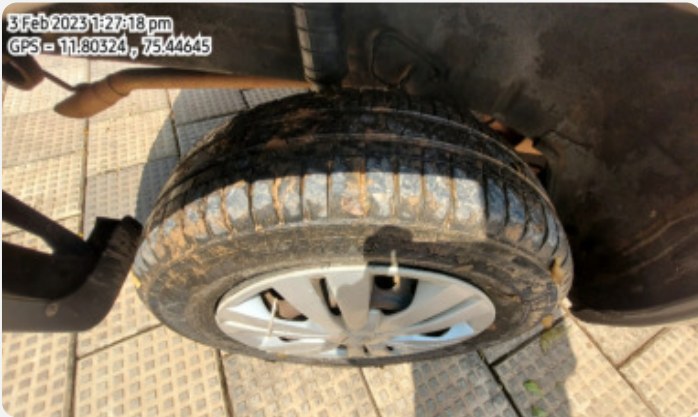
### Rear Right Tyre

**Rear right tyre**

Condition : **Satisfactory**

40%-60%

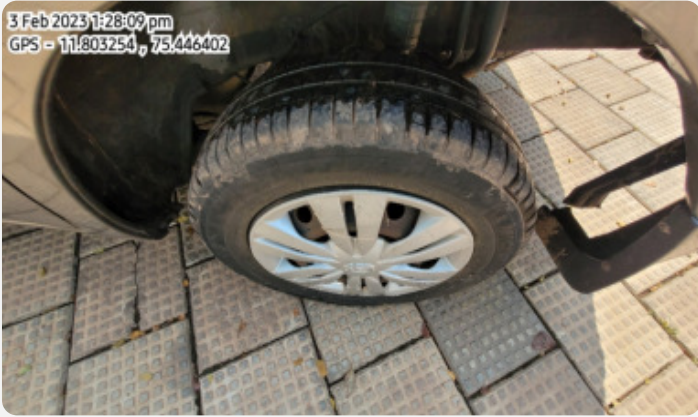
**Rear Left Tyre**

**Rear Left tyre**

Condition : **Satisfactory**

40%-60%

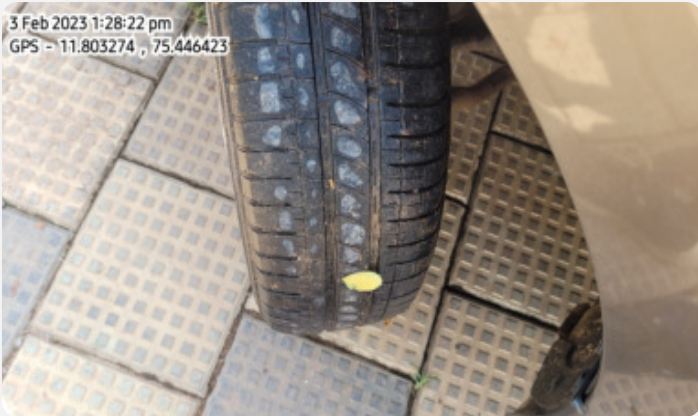
**Front Left Tyre**

**Front Left tyre**

Condition : **Satisfactory**

25-40%
