Mahindra First Choice Wheels Certification Report

2020 MARUTI SUZUKI ERTIGA(2018-2022) VXI BS-VI

Gurgaon | 33021 km | Petrol | Manual | White Colour | 1st Owner

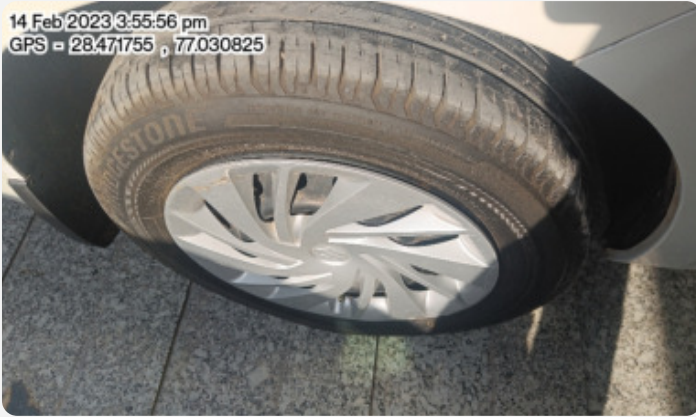
Front Right Tyre

Front right tyre

Condition : **Satisfactory**
40%-60%

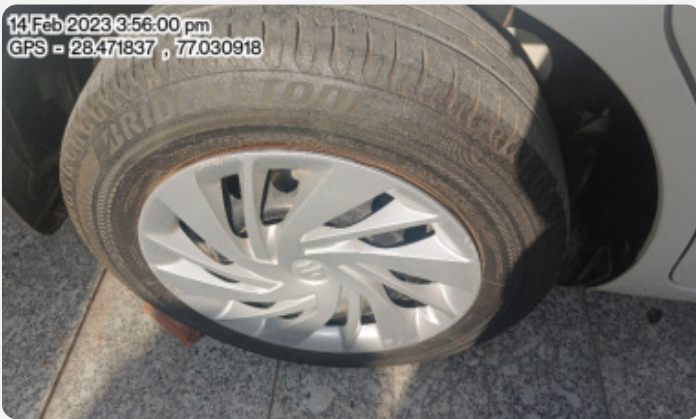
Rear Right Tyre

Rear right tyre

Condition : **Satisfactory**
40%-60%

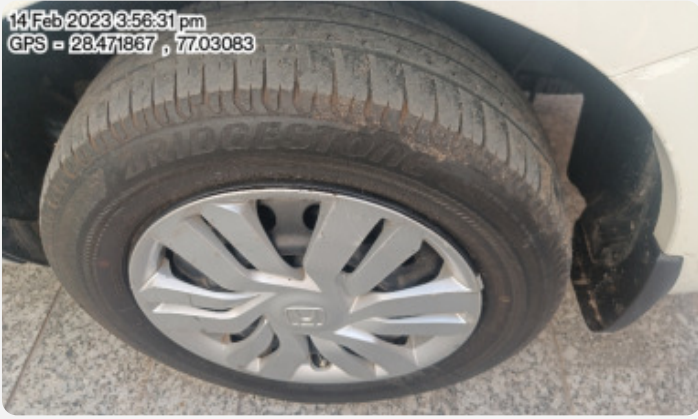
Rear Left Tyre

Rear Left tyre

Condition : **Satisfactory**

40%-60%

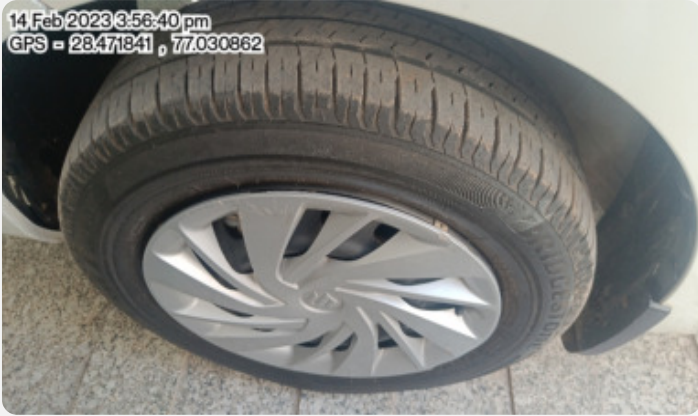
Front Left Tyre

Front Left tyre

Condition : **Satisfactory**

40%-60%

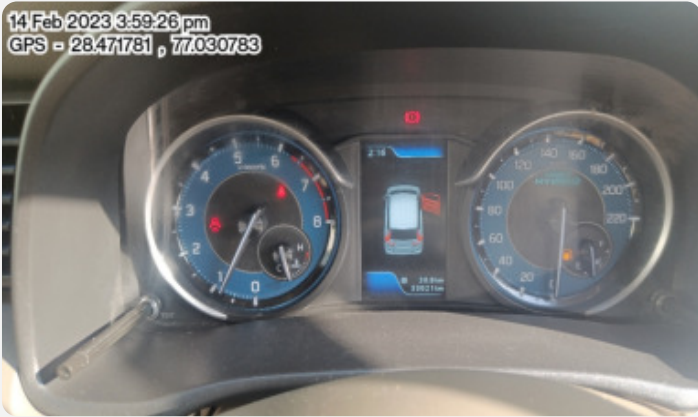
Odometer

**Instrument panel gauges:
Odometer**

Condition : **Excellent**
Good Condition
