## Mahindra First Choice Wheels Inspection Report

**2017 ISUZU D-MAX(2015-2019) SINGLE CAB**

Gurgaon | 85848 km | Diesel | Manual | Others Colour | 1st Owner

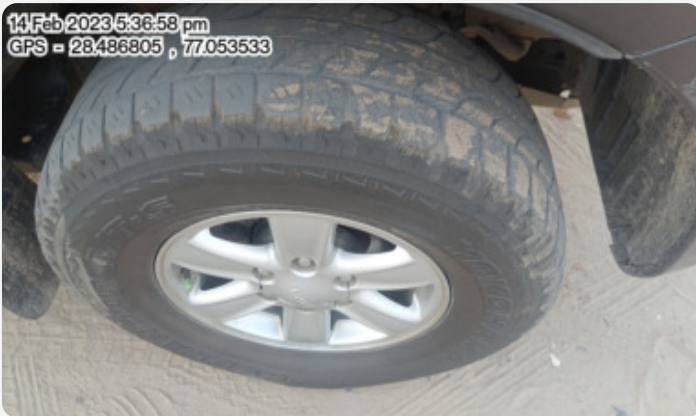
### Front Right Tyre

**Front right tyre**

Condition : **Bad**

Less than 20%

**tyres need change, service required**

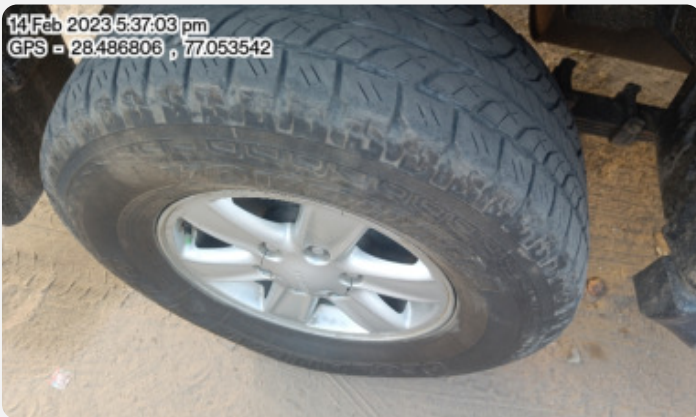
### Rear Right Tyre

**Rear right tyre**

Condition : **Bad**

Less than 20%

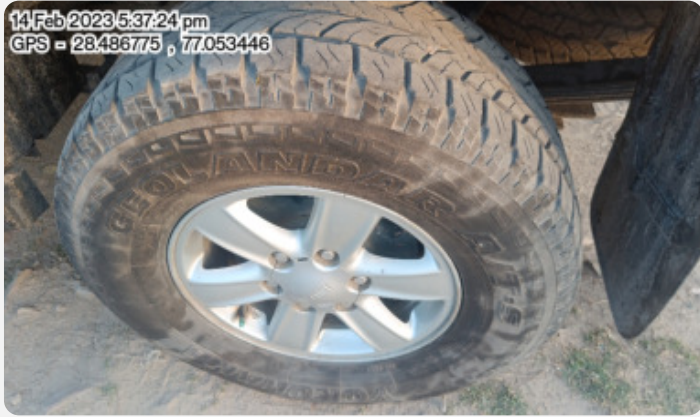
Rear Left Tyre

**Rear Left tyre**

Condition : **Bad**  
Less than 20%

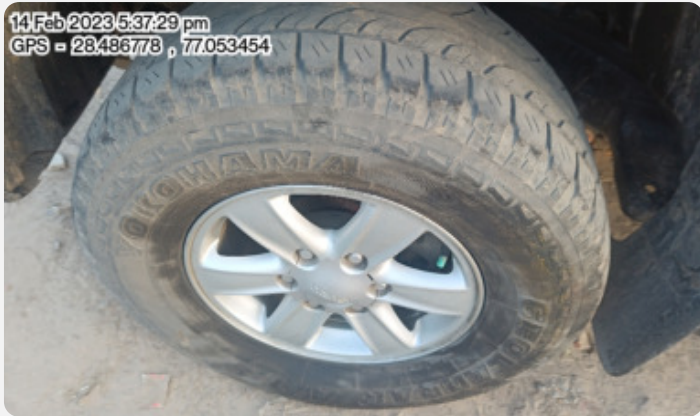
Front Left Tyre

**Front Left tyre**

Condition : **Bad**  
Less than 20%

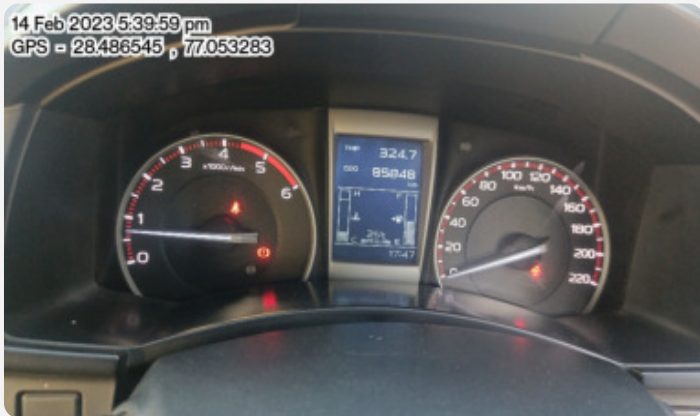
Odometer Reading(km)

**85848**
