## Mahindra First Choice Wheels Certification Report

## 2013 MAHINDRA BOLERO(2011-2016) ZLX BS IV

West Champaran | 78394 km | Diesel | Manual | White Colour | 2nd Owner

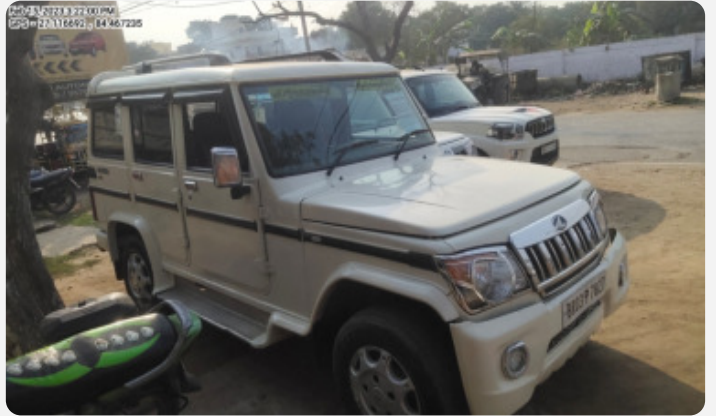
### Front Right Side

| <div>Rear Right Door handle</div> <div>Condition : Excellent</div> <div>Good Condition</div> | <div>Rear Right Window Glass</div> <div>Condition : Excellent</div> <div>Good Condition/Same Make</div> | <div>RH A Pillars</div> <div>Condition : Satisfactory</div> <div>Corrosion</div> |

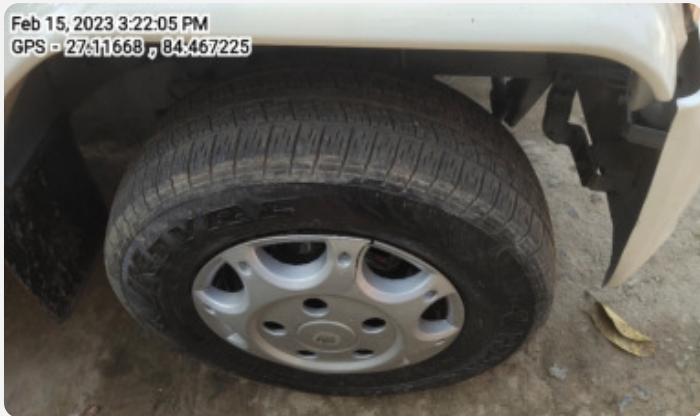
### Front Right Tyre

**Front right tyre**

Condition : **Satisfactory**

25-40%

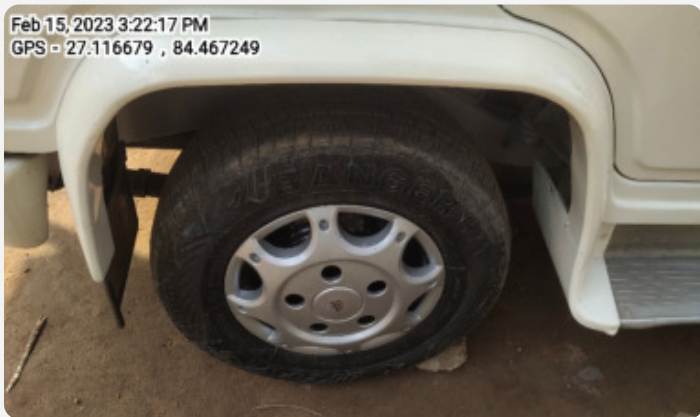
### Rear Right Tyre

**Rear right tyre**

Condition : **Satisfactory**

25-40%

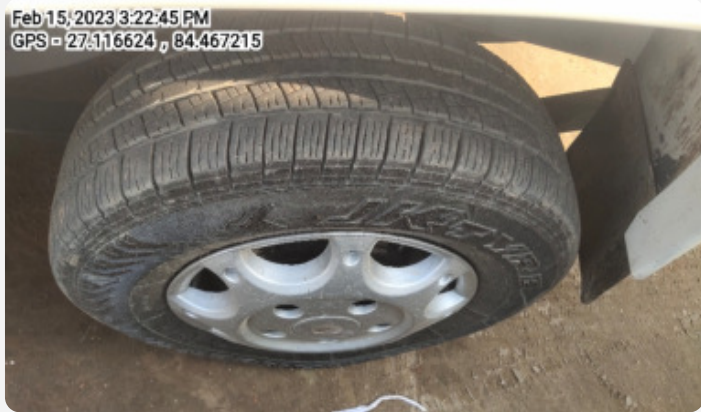
#### Rear Left Tyre

### Rear Left tyre

Condition : **Satisfactory**

25-40%

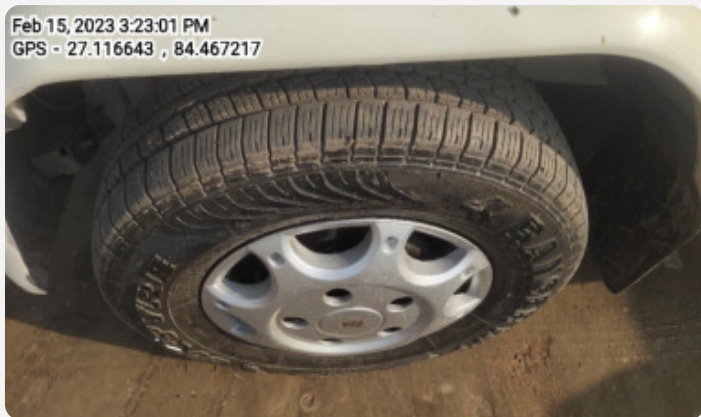
#### Front Left Tyre

### Front Left tyre

Condition : **Satisfactory**

25-40%

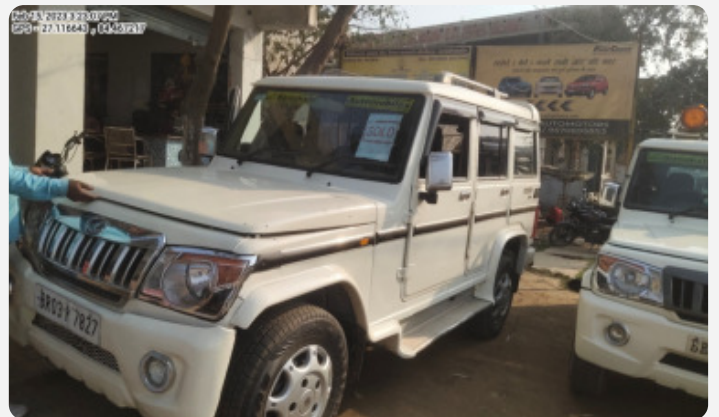
#### Front Left Side

**LH A Pillars**

Condition : **Satisfactory**

Corrosion
