Mahindra First Choice Wheels Certification Report

2018 HONDA CITY(2017-2020) V PETROL

New Delhi | 51706 km | Petrol | Manual | Others Colour | 1st Owner

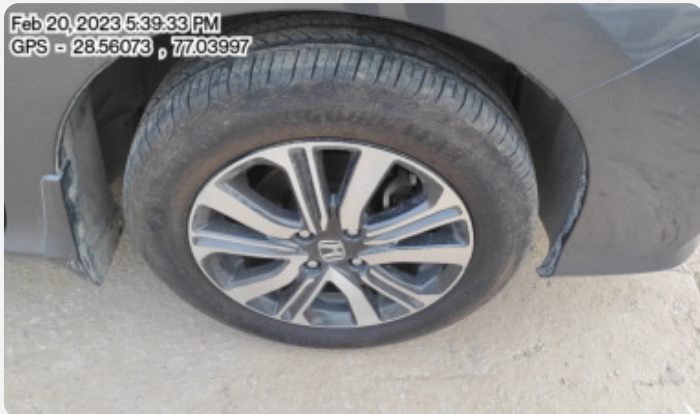
Front Right Tyre

Front right tyre

Condition : **Good**

60%-80%

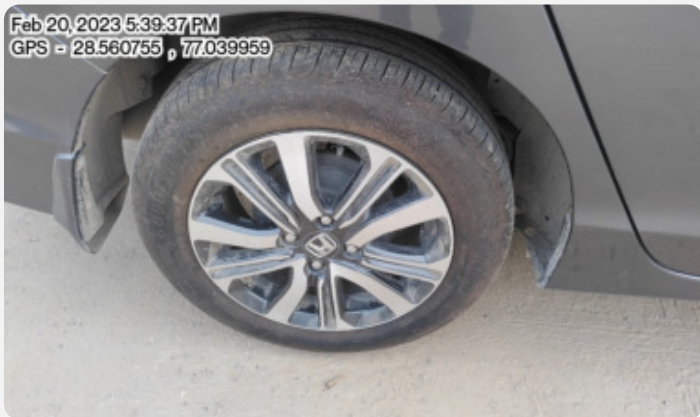
Rear Right Tyre

Rear right tyre

Condition : **Good**

60%-80%

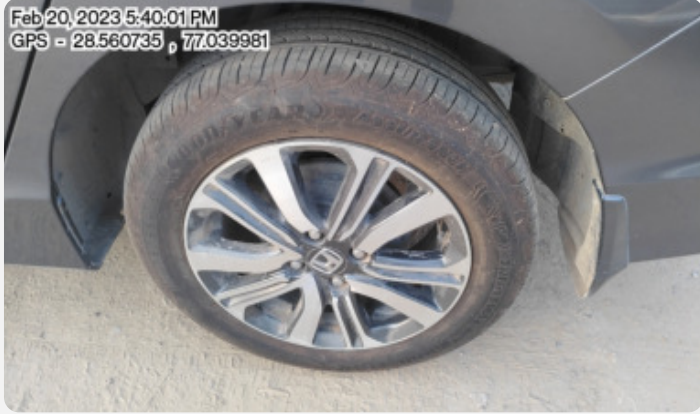
Rear Left Tyre

Rear Left tyre

Condition : **Good**

60%-80%

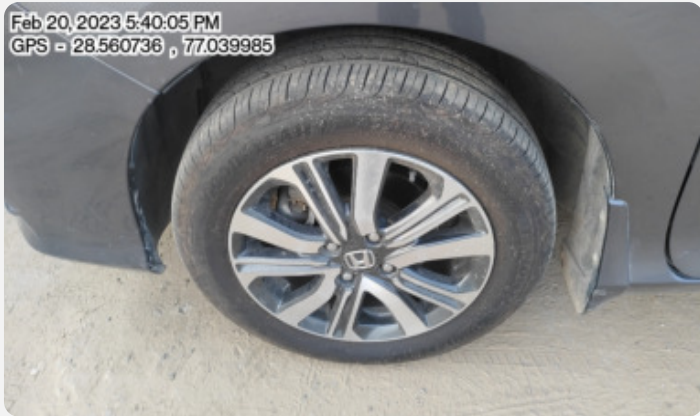
Front Left Tyre

Front Left tyre

Condition : **Good**

60%-80%

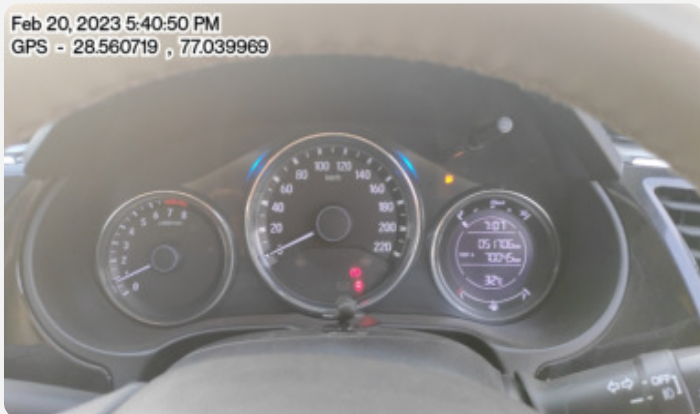
Instrument panel gauges: Odometer

Condition : **Excellent**

Good Condition
