## Mahindra First Choice Wheels Certification Report

**2013 MARUTI SUZUKI SWIFT DZIRE(2011-2015) VXI**

Thane | 42173 km | Petrol | Manual | Others Colour | 1st Owner

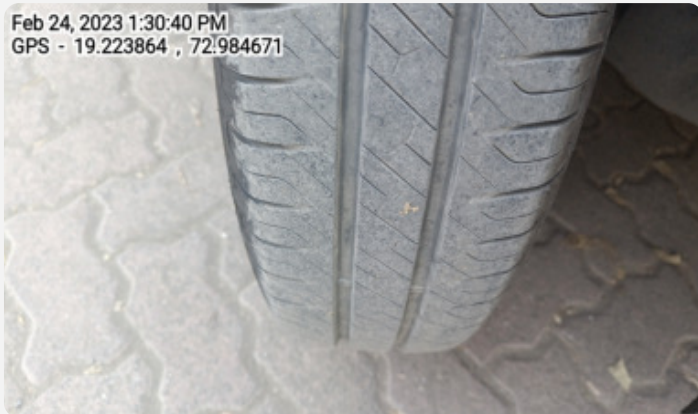
### Front Right Tyre

**Front right tyre**

Condition : **Satisfactory**

40%-60%

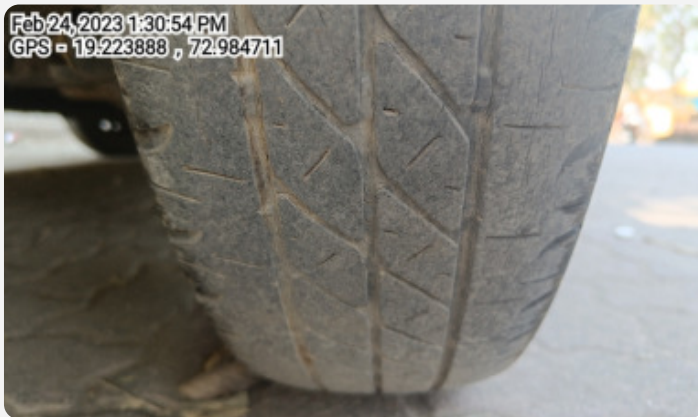
### Rear Right Tyre

**Rear right tyre**

Condition : **Bad**

Less than 20%

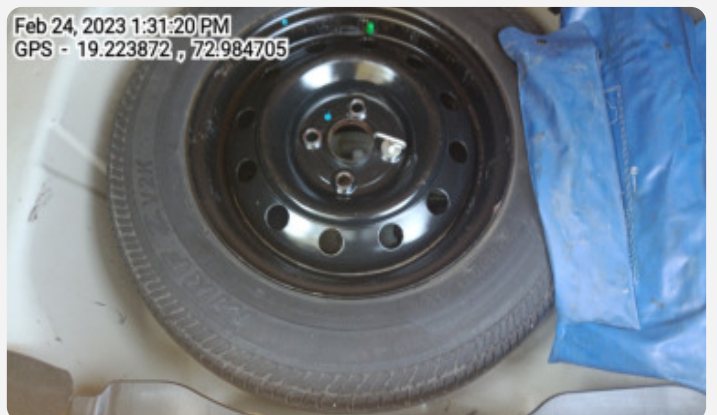
### Spare Tyre

**Spare tyre (stephney)**

Condition : **Satisfactory**

Same Make/ Good & > 40% life

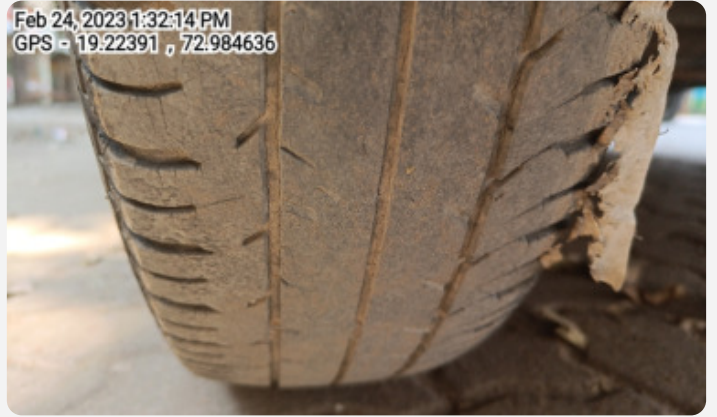
#### Rear Left Tyre

**Rear Left tyre**

Condition : **Bad**

Less than 20%

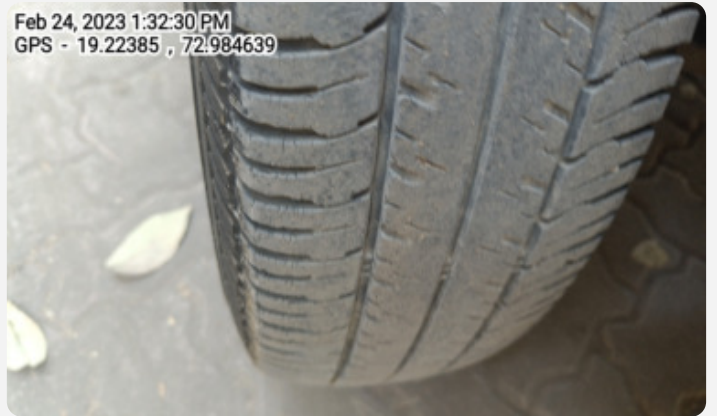
#### Front Left Tyre

**Front Left tyre**

Condition : **Satisfactory**

25-40%
