Mahindra First Choice Wheels Certification Report

**2021 JEEP COMPASS S O 2.0 DIESEL 4X4 AT**

Gurgaon | 30742 km | Diesel | Automatic (dual Clutch) | Others Colour | 1st Owner

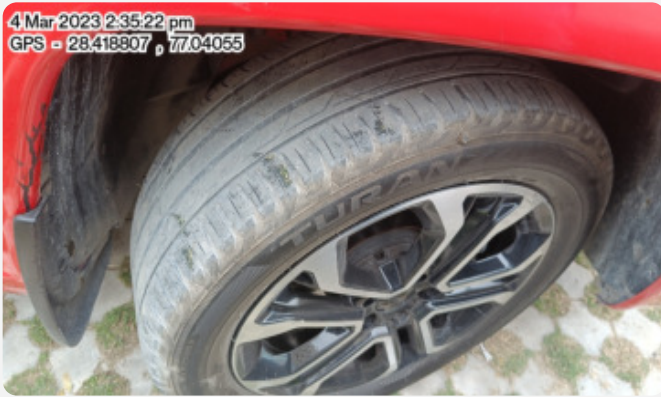
Front Right Tyre

Front right tyre

Condition : **Satisfactory**

40%-60%

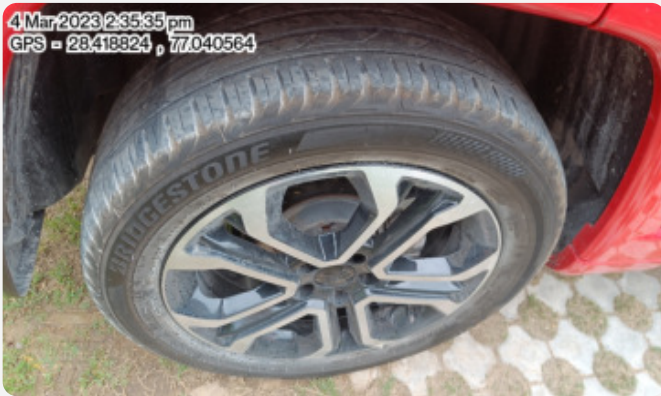
Rear Right Tyre

Rear right tyre

Condition : **Satisfactory**

40%-60%

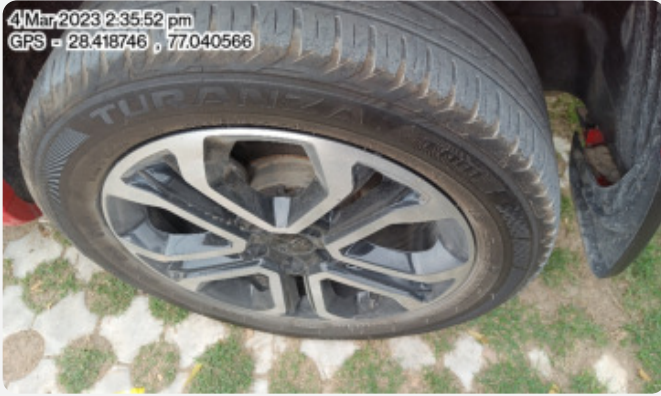
Rear Left Tyre

Rear Left tyre

Condition : **Satisfactory**

40%-60%

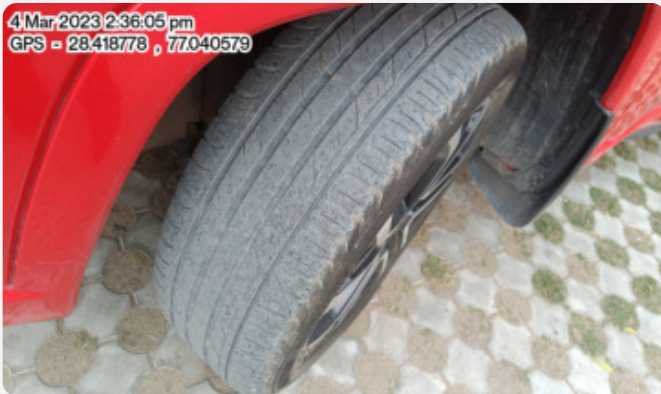
Front Left Tyre

Front Left tyre

Condition : **Satisfactory**

40%-60%

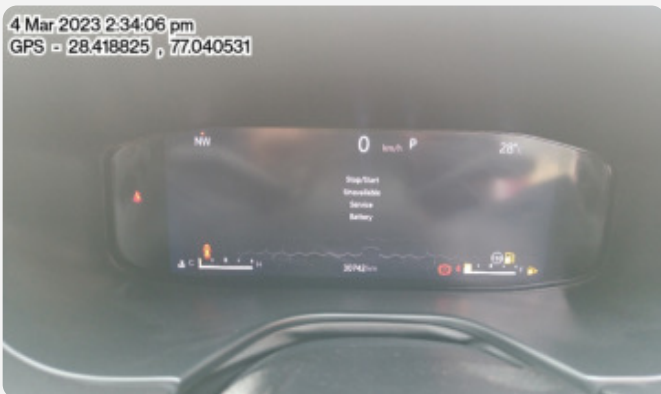
Odometer

**Instrument panel gauges:
Odometer**

Condition : **Excellent**

Good Condition
