## Mahindra First Choice Wheels Certification Report

**2017 MARUTI SUZUKI CELERIO(2017-2019) VXI AMT**

Kozhikode | 47356 km | Petrol | Amt | Grey Colour | 1st Owner

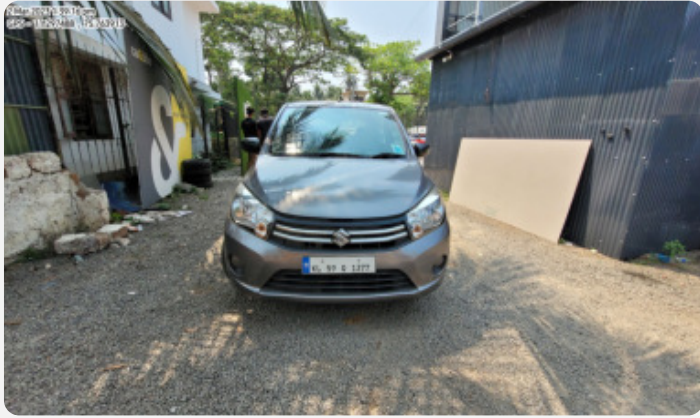
### Front Side

**Front Bumper**

Condition : Good

Deep/long Scratches-2 & Above

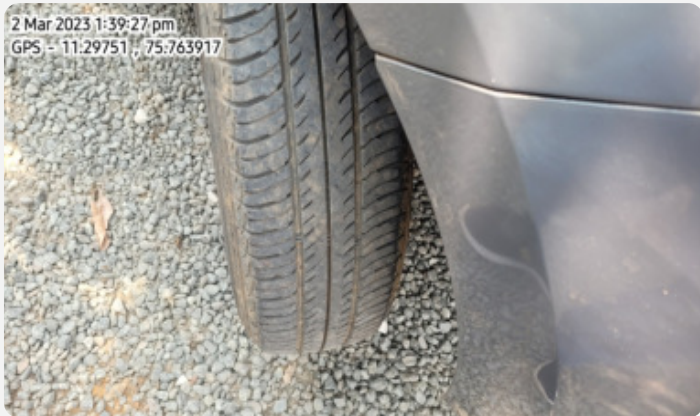
### Front Right Tyre

**Front right tyre**

Condition : **Satisfactory**

25-40%

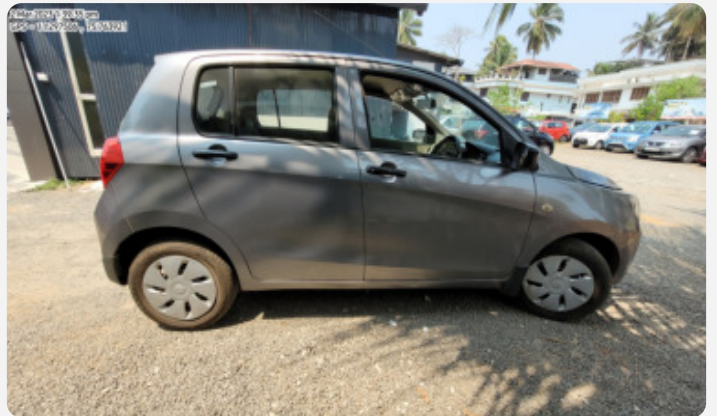
### Right Side

**Front Right Door**

Condition : Satisfactory

Replaced - Not Original

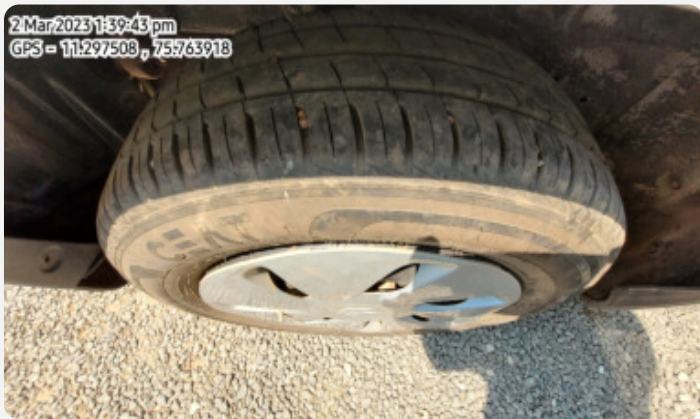
### Rear Right Tyre

**Rear right tyre**

Condition : **Satisfactory**

40%-60%

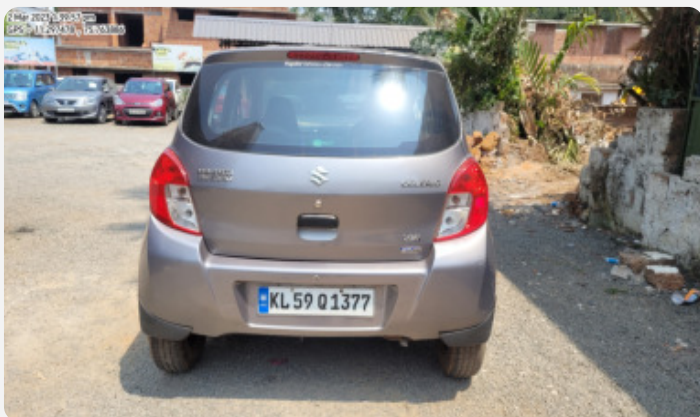
### Back Side

**Rear Bumper**

Condition : **Good**

Deep/long Scratches-2 & Above

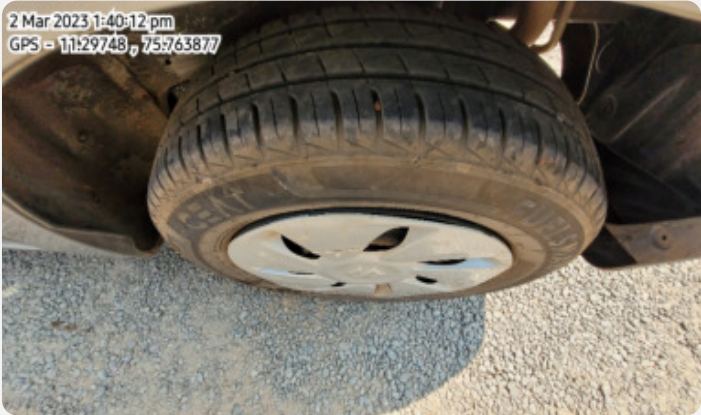
Rear Left Tyre

### Rear Left tyre

Condition : **Satisfactory**

40%-60%

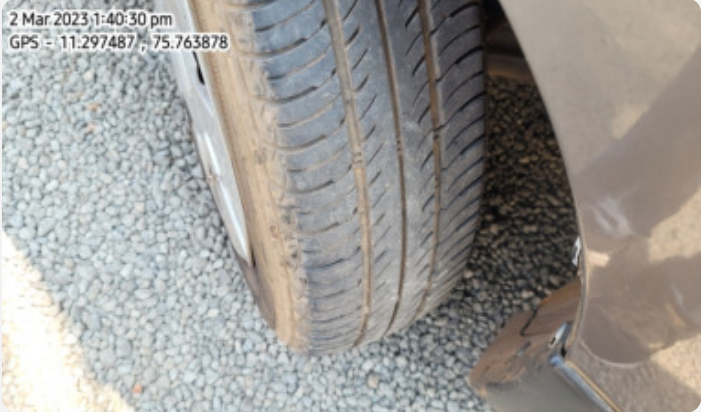
Front Left Tyre

### Front Left tyre

Condition : **Satisfactory**

25-40%

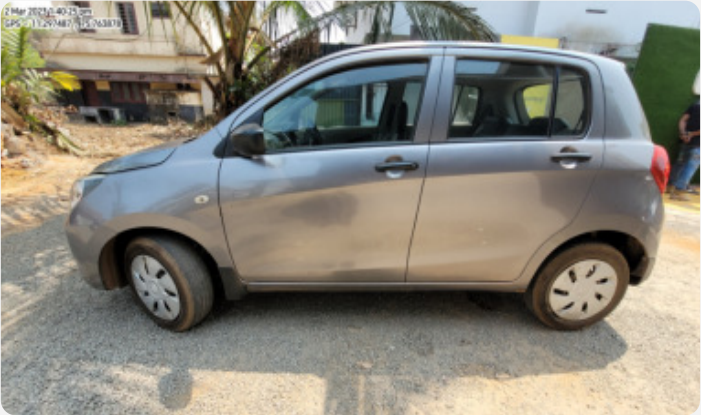
Left Side

**Left Running Board**

Condition : **Satisfactory**

Deep/long Scratches

**Left Fender**

Condition : **Bad**

Dent with Paint Damage
