## Mahindra First Choice Wheels Inspection Report

**2018 MARUTI SUZUKI EECO(2010-2020) 5 STR WITH A/C+HTR CNG**

Ujjain | 56893 km | Petrol | Manual | Black Colour | 1st Owner

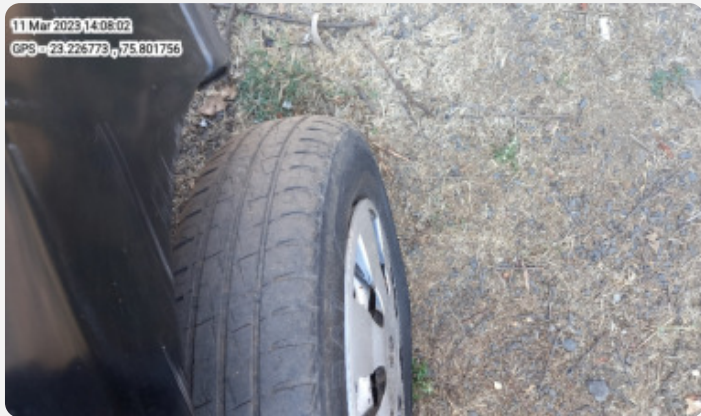
### Front Right Tyre

**Front right tyre**

Condition : **Bad**

Less than 20%

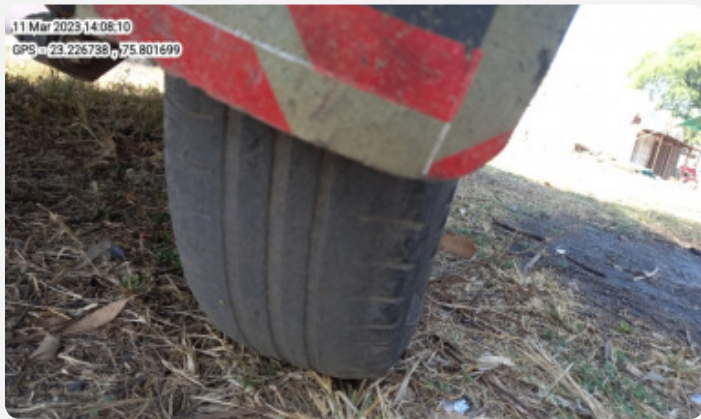
### Rear Right Tyre

**Rear right tyre**

Condition : **Bad**

Less than 20%

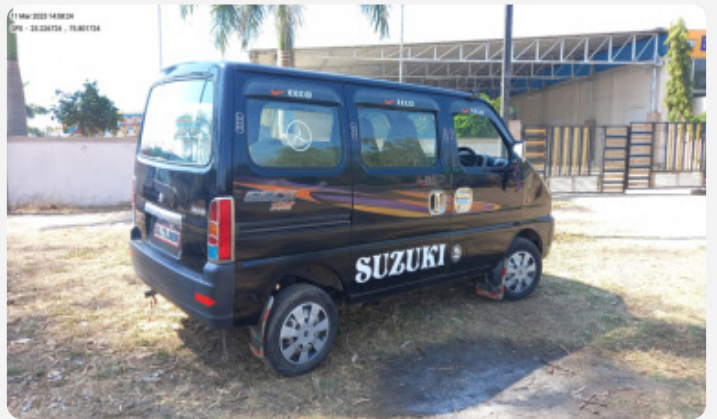
### Rear Right Side

**Right Quarter Panel**

Condition : **Good**

Dent without Paint Damage

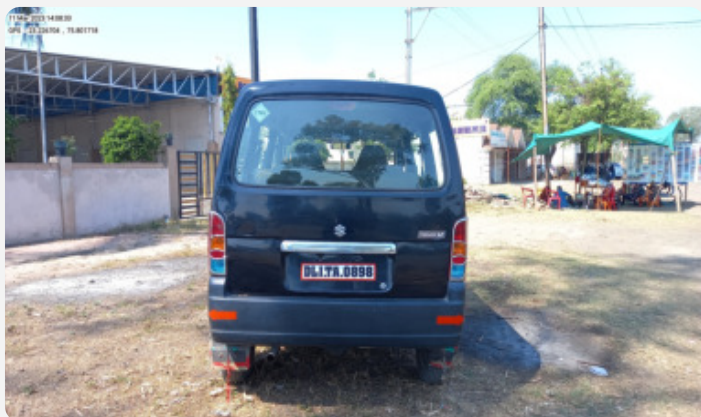
### Back Side

**Rear Bumper**

Condition : **Excellent**

Light/Short Scratches-under 2

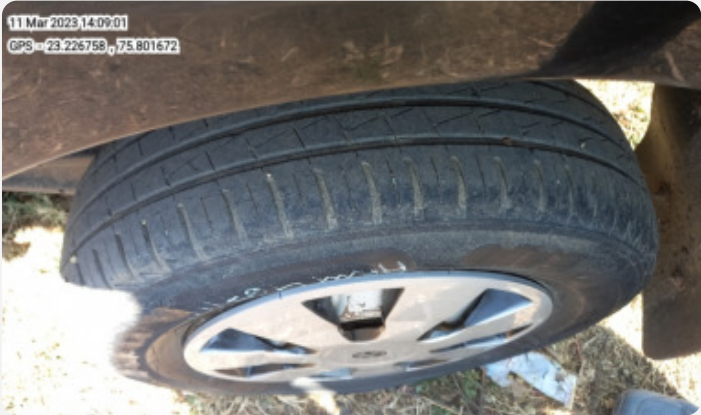
Rear Left Tyre

**Rear Left tyre**

Condition : **Satisfactory**

25-40%

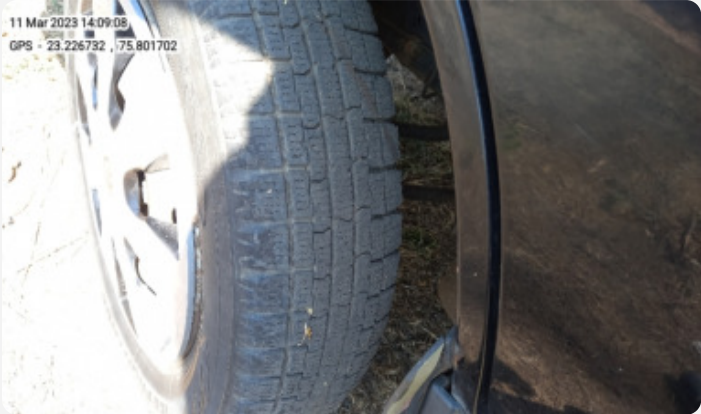
Front Left Tyre

**Front Left tyre**

Condition : **Satisfactory**

25-40%
