Mahindra First Choice Wheels Certification Report

**2017 HYUNDAI CRETA(2015-2018) 1.6 SX CRDI**

Pune | 60583 km | Diesel | Manual | White Colour | 1st Owner

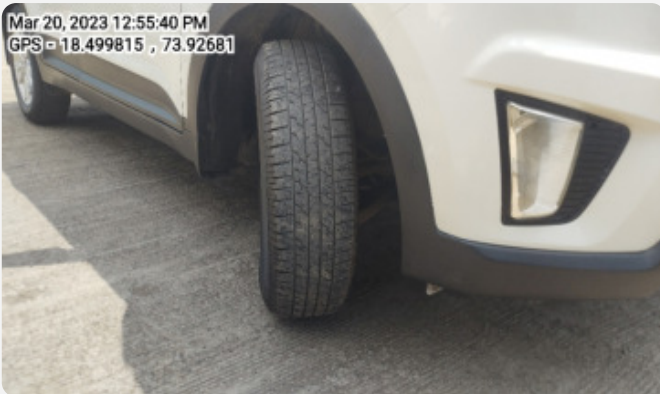
Front Right Tyre

Above 80% life

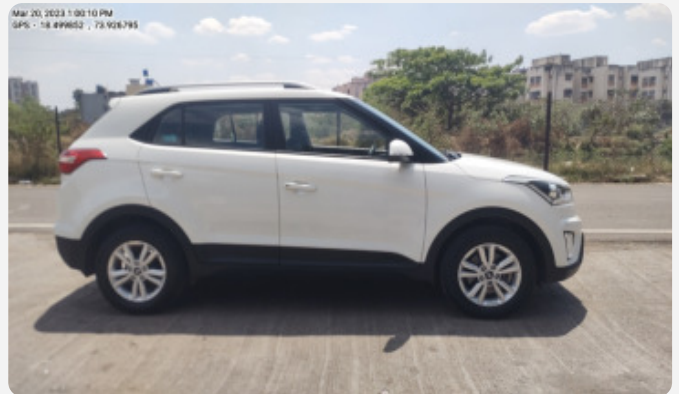
Right Side

Deep/long Scratches-under 2

Dent without Paint Damage

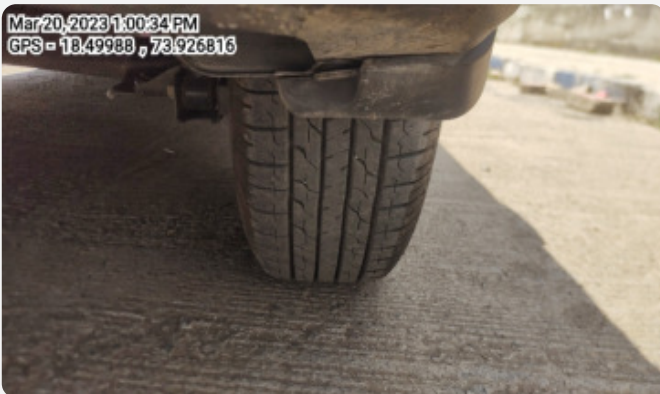
Rear Right Tyre

Above 80% life

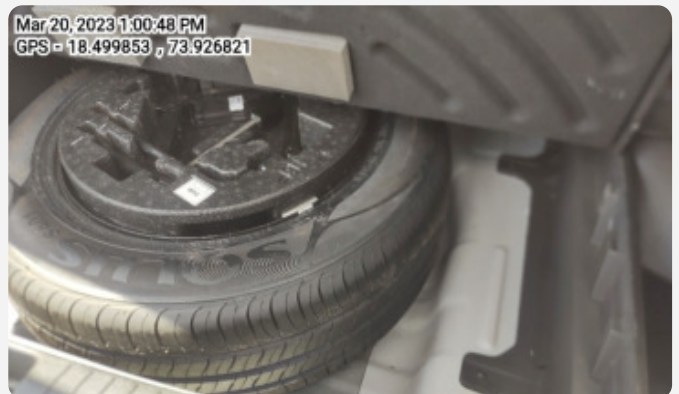
Spare Tyre

Same Make/ Good & > 80% life

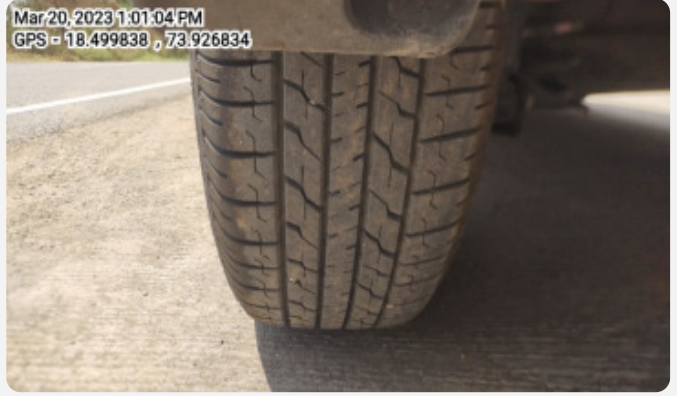
Rear Left Tyre

Condition : **Excellent**
Above 80% life

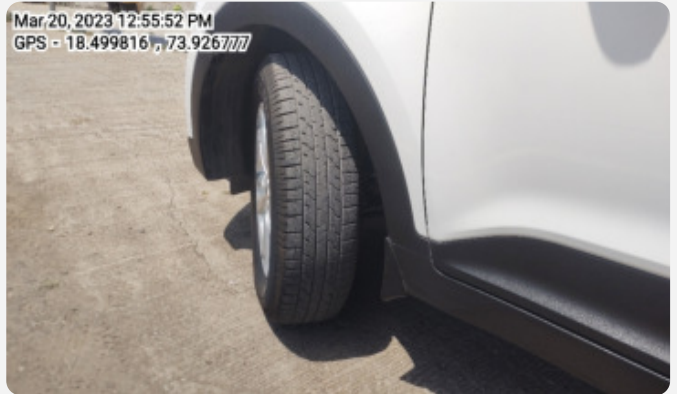
Front Left Tyre

Above 80% life

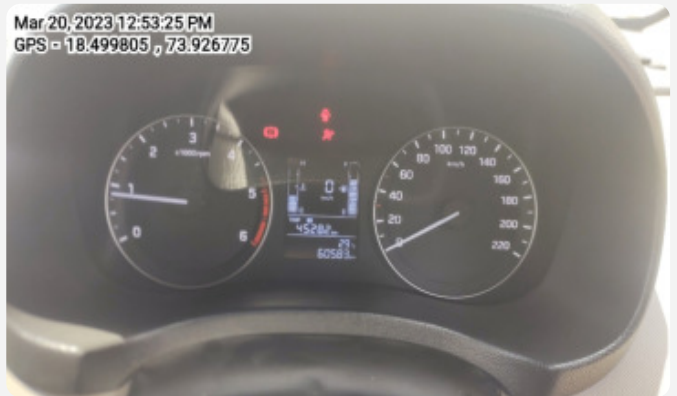
Odometer

Good Condition
