Mahindra First Choice Wheels Inspection Report

2011 TOYOTA ETIOS(2010-2013) G

Pimpri Chinchwad | 74601 km | Petrol | Manual | Beige Colour | 2nd Owner

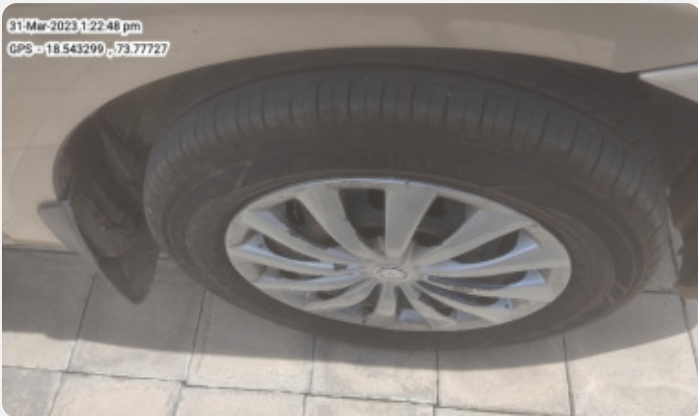
Front Right Tyre

Front right tyre

Condition : **Satisfactory**

25-40%

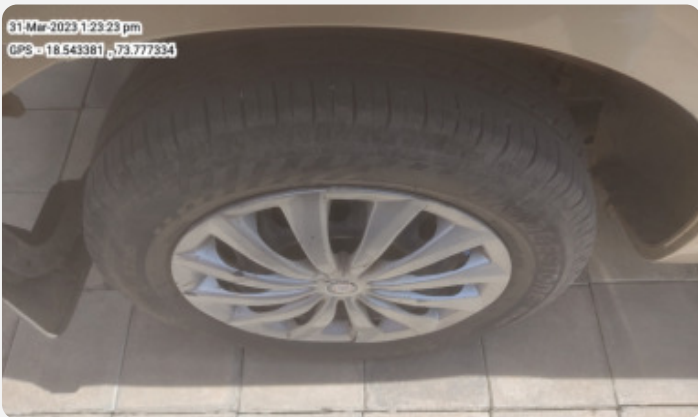
Rear Right Tyre

Rear right tyre

Condition : **Satisfactory**

25-40%

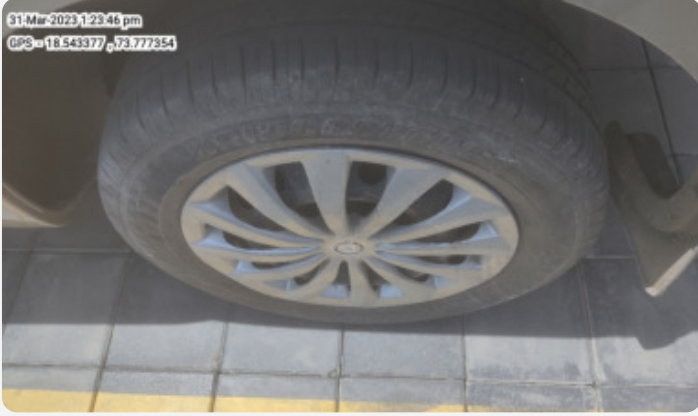
Rear Left Tyre

Rear Left tyre

Condition : **Satisfactory**

25-40%

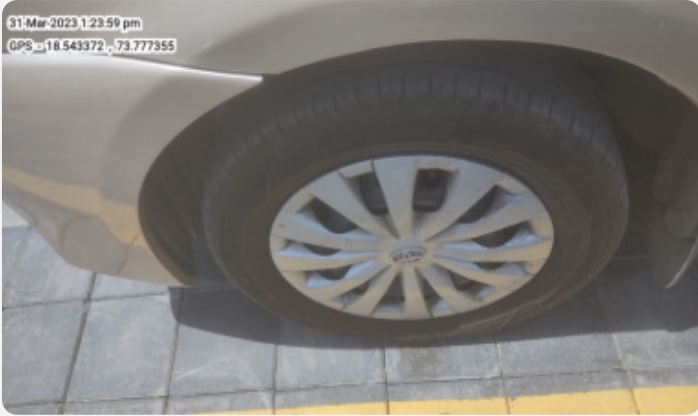
Front Left Tyre

Front Left tyre

Condition : **Satisfactory**
25-40%

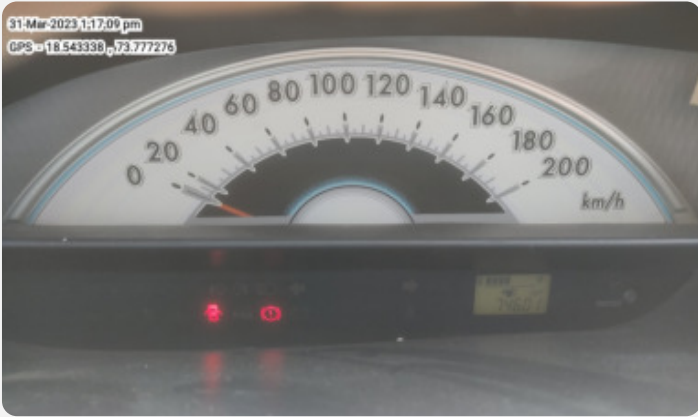
Odometer

**Instrument panel gauges:
Odometer**

Condition : **Excellent**
Good Condition
