Mahindra First Choice Wheels Certification Report

2014 TOYOTA ETIOS(2014-2016) V

Dehradun | 70376 km | Petrol | Manual | Silver Colour | 1st Owner

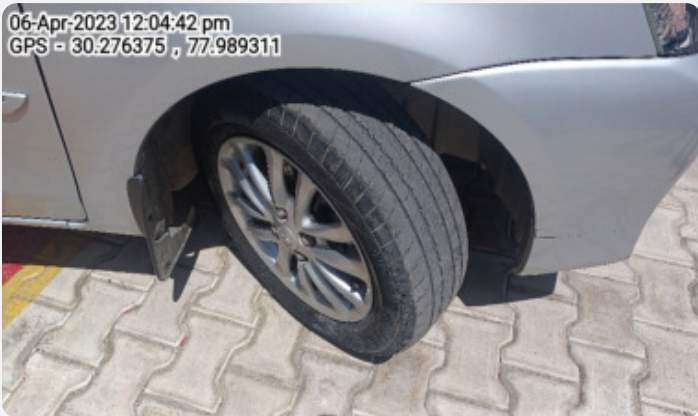
Front Right Tyre

Condition : **Satisfactory**
25-40%

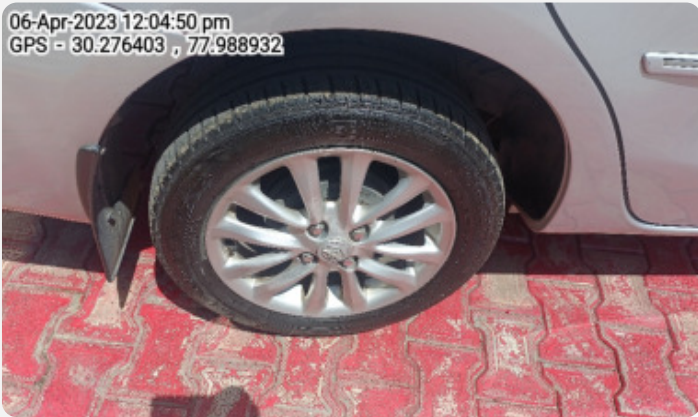
Rear Right Tyre

Condition : **Satisfactory**
25-40%

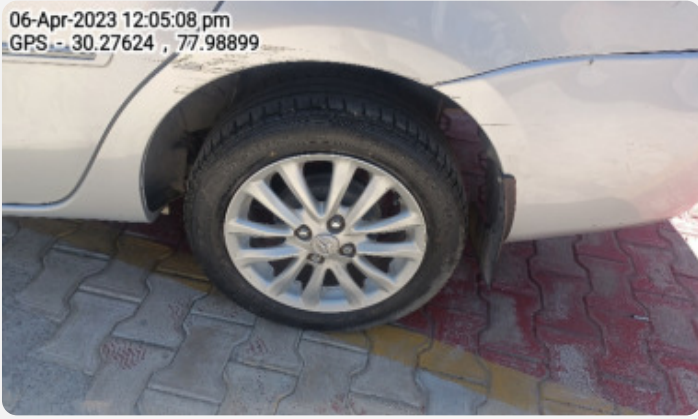
Rear Left Tyre

Condition : **Satisfactory**
40%-60%

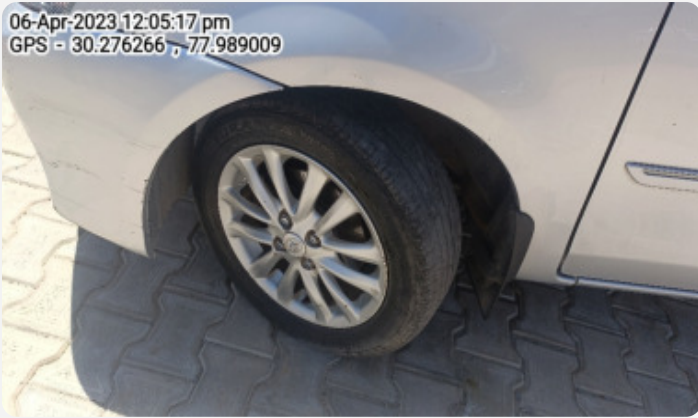
Front Left Tyre

Condition : **Satisfactory**
25-40%
