Mahindra First Choice Wheels Inspection Report

2012 HYUNDAI ELANTRA(2012-2015) 1.6 SX AT

Pathankot | 138123 km | Diesel | Automatic | Silver Colour | 2nd Owner

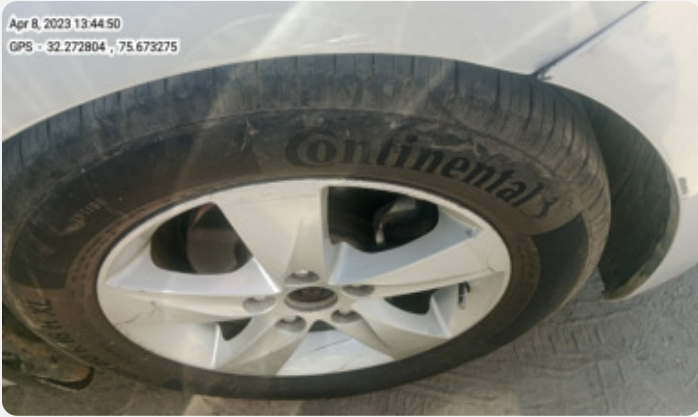
Front Right Tyre

Condition : **Satisfactory**

40%-60%

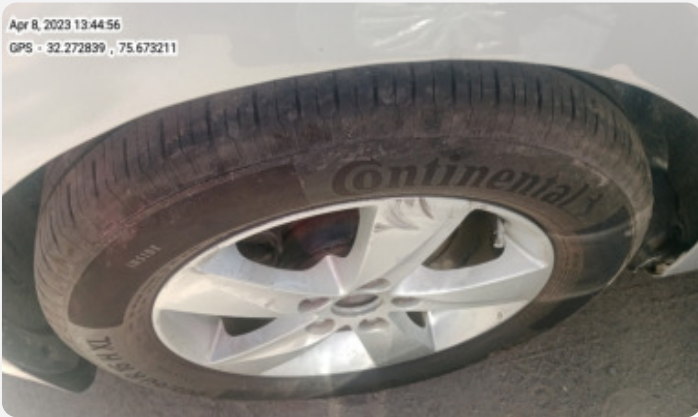
Rear Right Tyre

Condition : **Satisfactory**

40%-60%

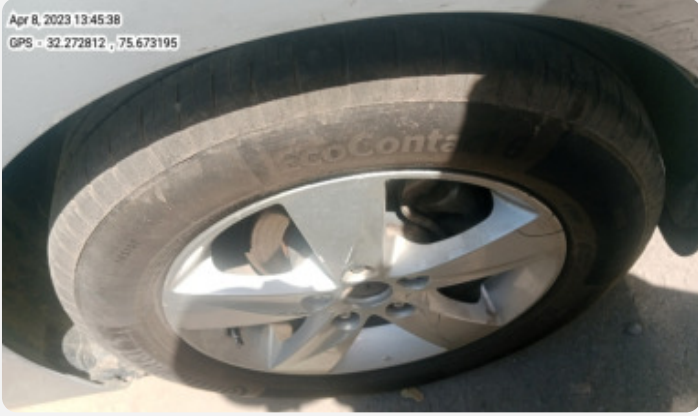
Rear Left Tyre

Condition : **Satisfactory**

40%-60%

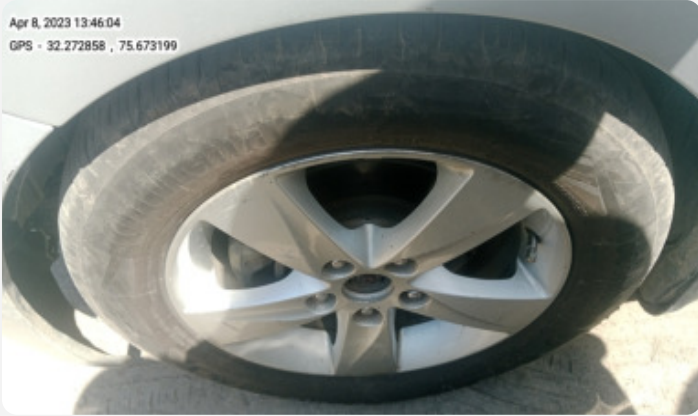
Front Left Tyre

Condition : **Satisfactory**
40%-60%
