Mahindra First Choice Wheels Certification Report

2018 MARUTI SUZUKI DZIRE(2017-2020) ZXI AMT

Kozhikode | 39281 km | Petrol | Amt | White Colour | 1st Owner

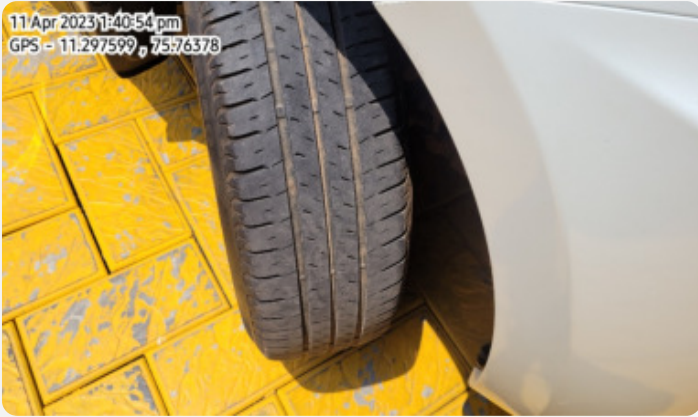
Front Right Tyre

Condition : **Satisfactory**
25-40%

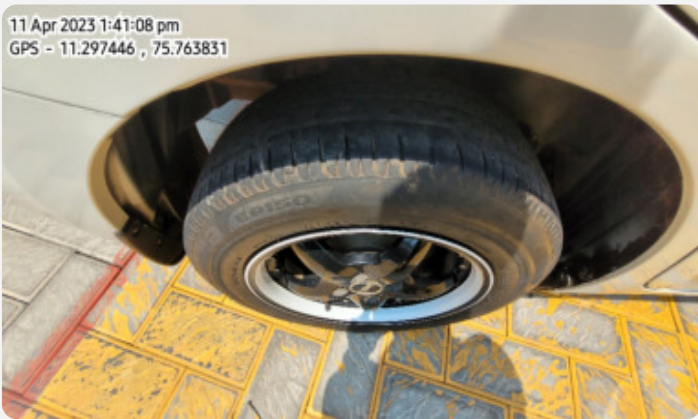
Rear Right Tyre

Condition : **Satisfactory**
25-40%

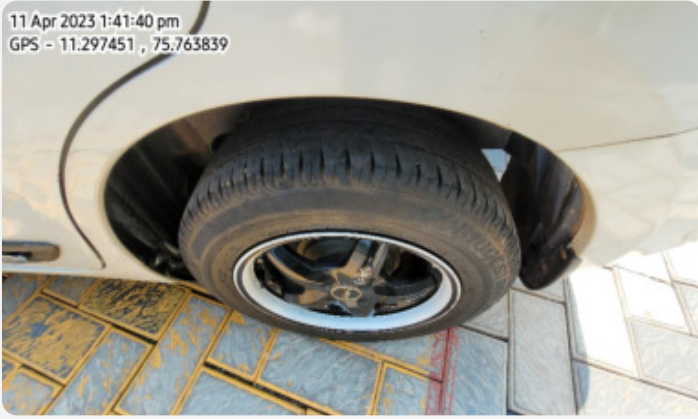
Rear Left Tyre

25-40%

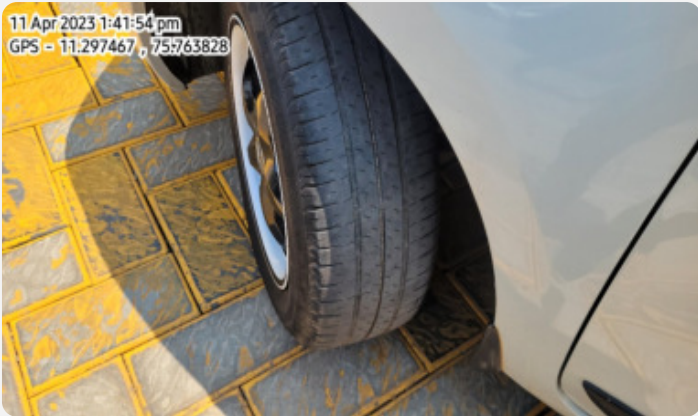
Front Left Tyre

25-40%

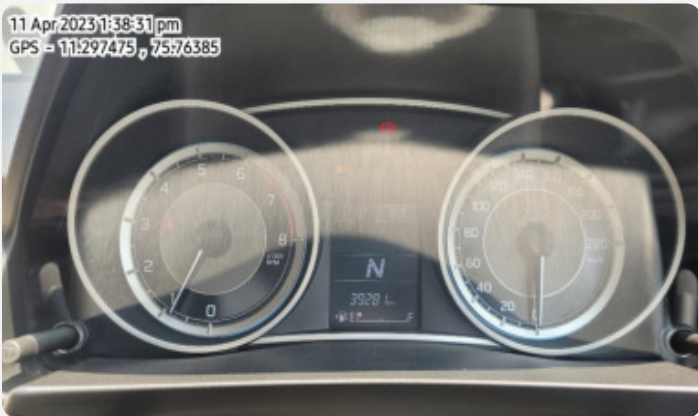
Odometer

Condition : **Excellent**
Good Condition
