Mahindra First Choice Wheels Certification Report

**2020 HONDA CITY ZX CVT PETROL BS-VI**

New Delhi | 18533 km | Petrol | Automatic Cvt | Others Colour | 1st Owner

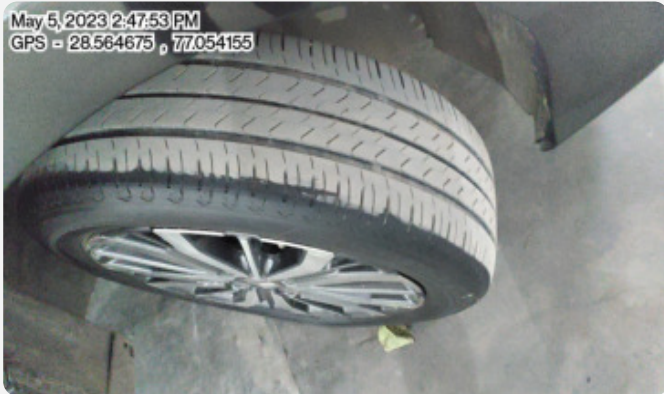
Front Right Tyre

Front right tyre

Condition : **Satisfactory**

40%-60%

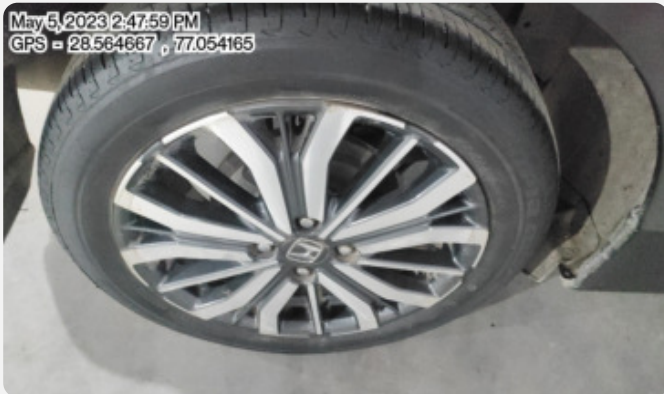
Rear Right Tyre

Rear right tyre

Condition : **Satisfactory**

40%-60%

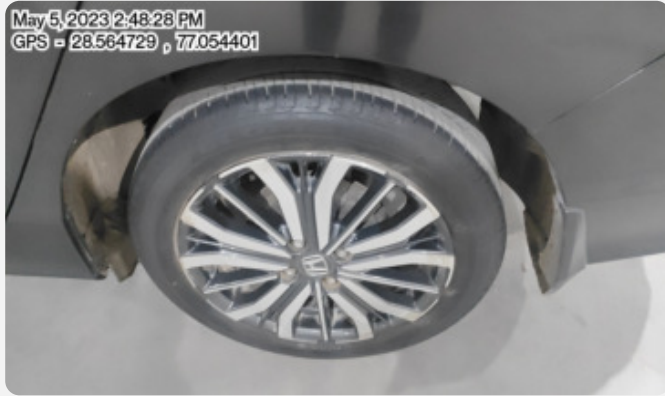
Rear Left Tyre

Rear Left tyre

Condition : **Satisfactory**

40%-60%

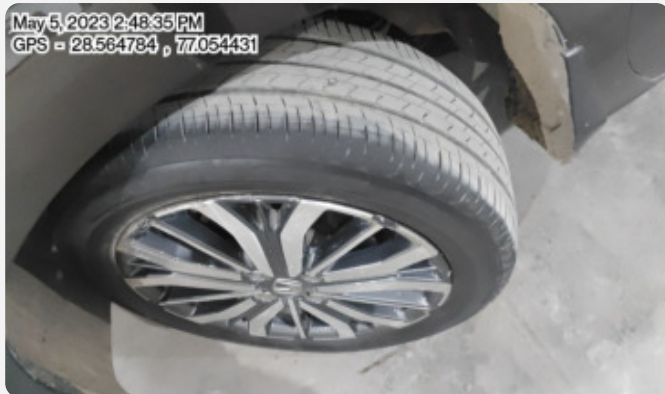
Front Left Tyre

Front Left tyre

Condition : **Satisfactory**

40%-60%

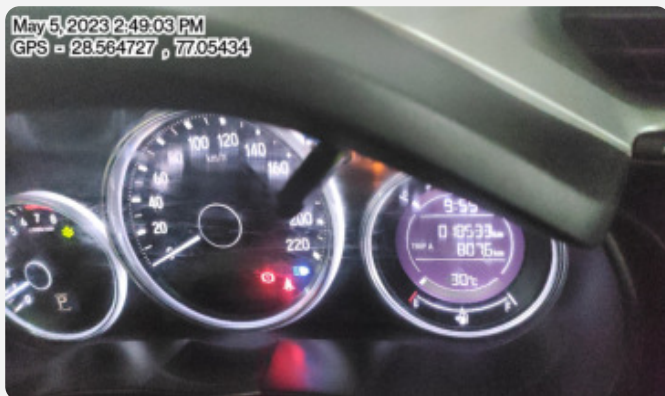
Odometer

**Instrument panel gauges:
Odometer**

Condition : **Excellent**

Good Condition
