Mahindra First Choice Wheels Certification Report

2015 MAHINDRA SCORPIO(2014-2017) S4

West Champaran | 57205 km | Diesel | Manual | White Colour | 2nd Owner

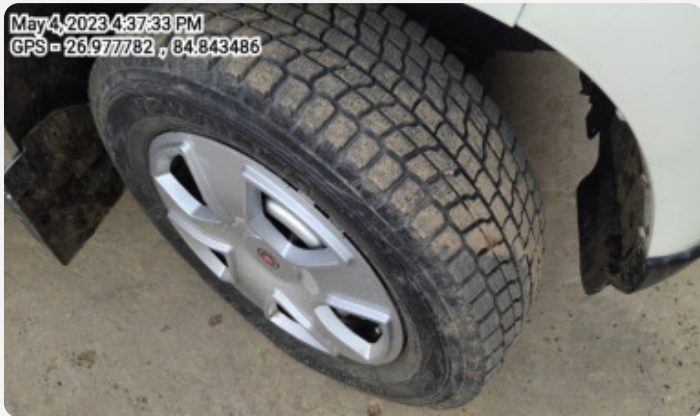
Front Right Tyre

Condition : **Satisfactory**

40%-60%

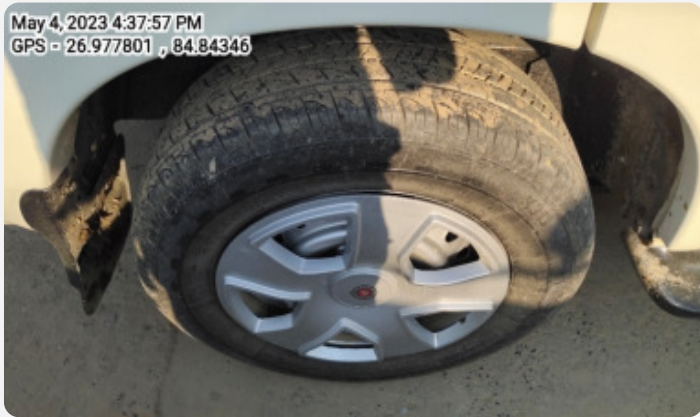
Rear Right Tyre

Condition : **Satisfactory**

40%-60%

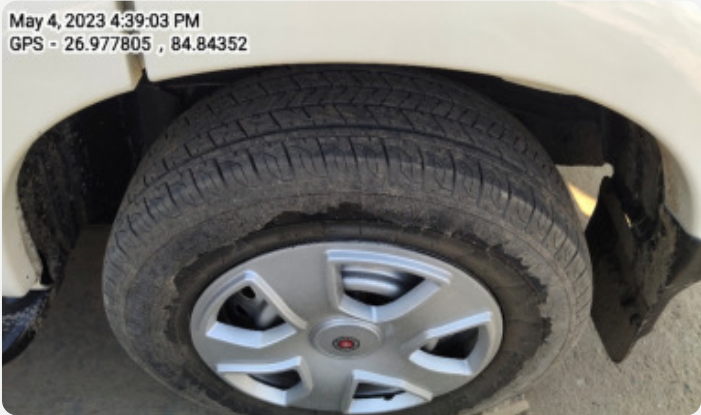
Rear Left Tyre

Condition : **Satisfactory**

40%-60%

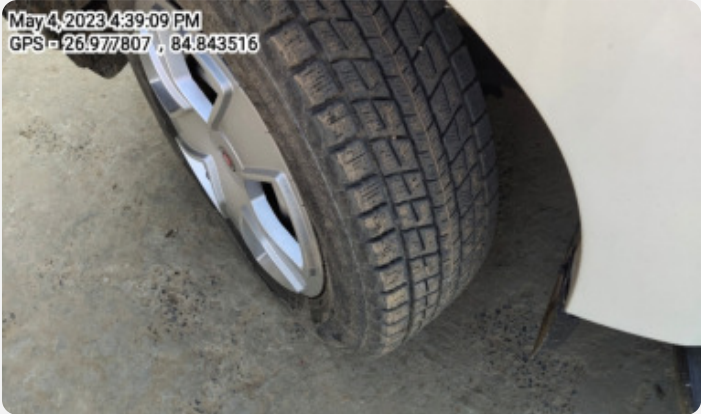
Front Left Tyre

Condition : **Satisfactory**

40%-60%

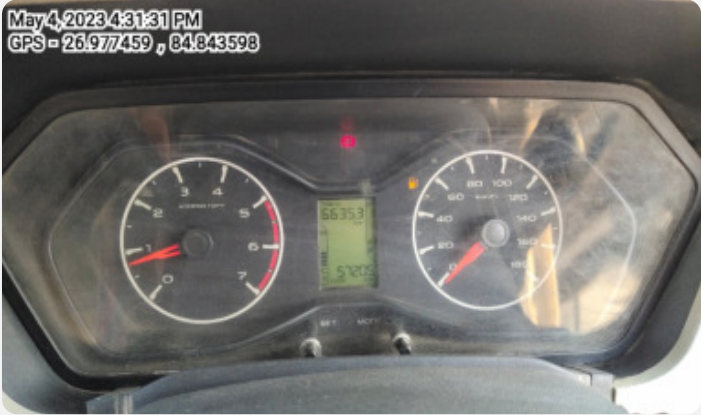
Odometer Reading(km)

57205

Condition : **Excellent**

Good Condition
