## Mahindra First Choice Wheels Certification Report

**2018 MARUTI SUZUKI ALTO K10(2015-2019) VXI**

Udham Singh Nagar | 42729 km | Petrol | Manual | Others Colour | 1st Owner

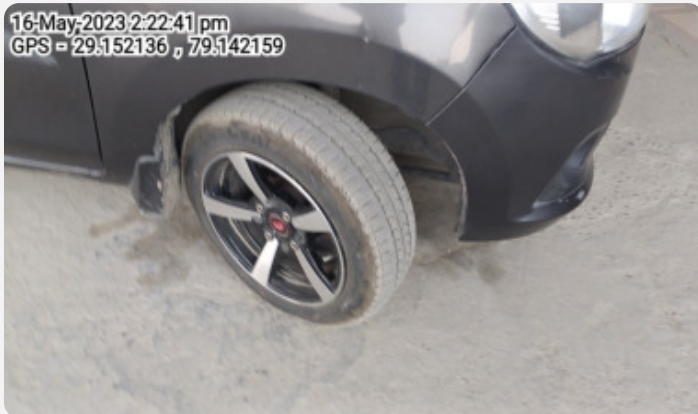
### Front Right Tyre

**Front right tyre**

Condition : **Satisfactory**

25-40%

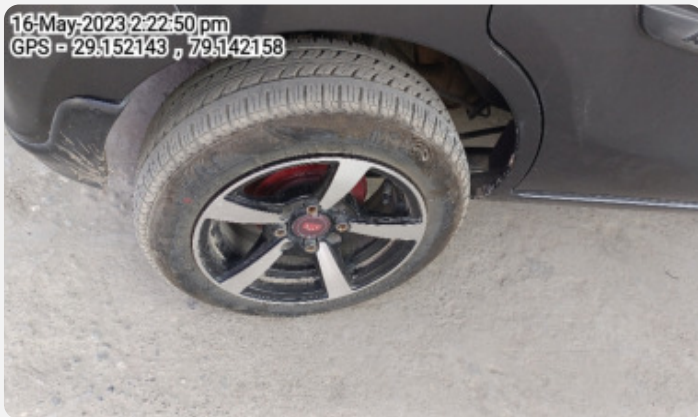
### Rear Right Tyre

**Rear right tyre**

Condition : **Satisfactory**

40%-60%

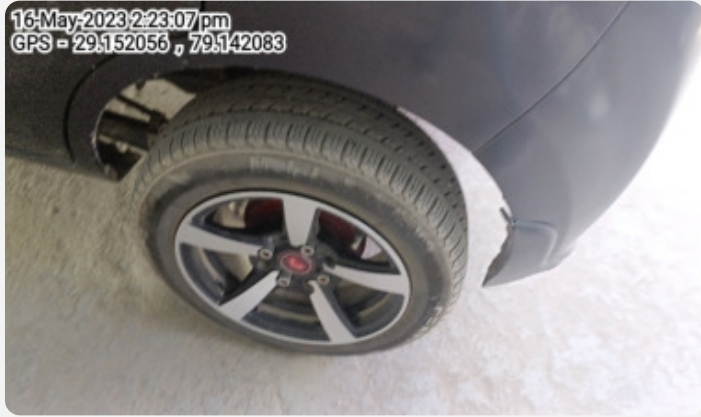
Rear Left Tyre

### Rear Left tyre

Condition : **Satisfactory**

40%-60%

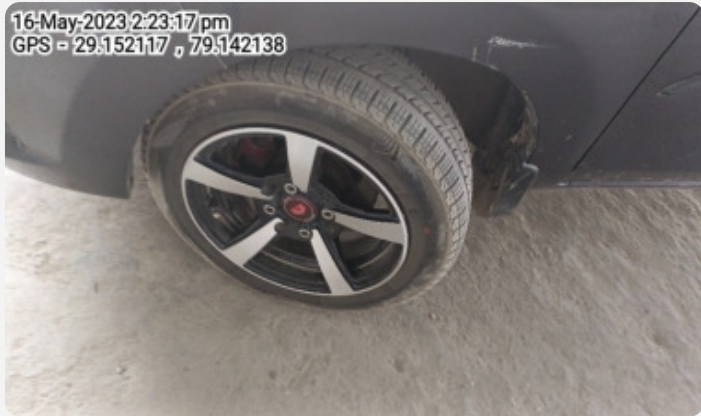
Front Left Tyre

**Front Left tyre**

Condition : **Satisfactory**

40%-60%

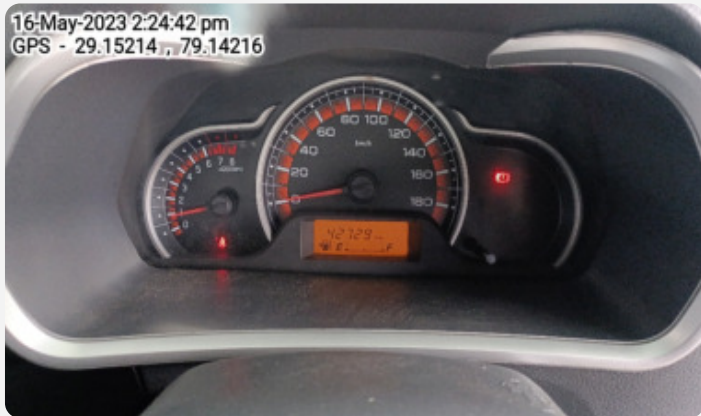
Odometer Reading(km)

**42729**
