Mahindra First Choice Wheels Certification Report

**2019 KIA SELTOS(2019-2020) GTX AT 1.4**

New Delhi | 25917 km | Petrol | Automatic | Others Colour | 1st Owner

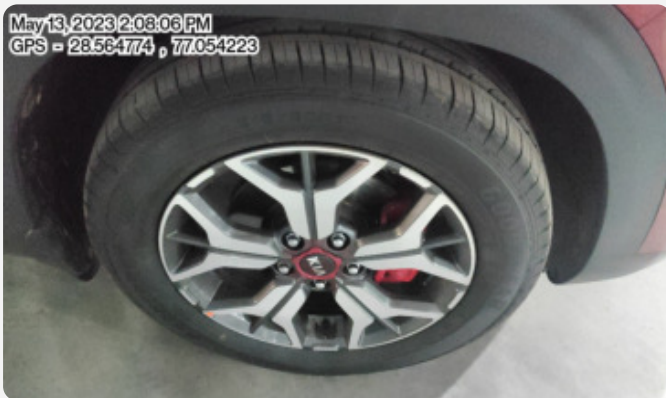
Front Right Tyre

Condition : **Satisfactory**

40%-60%

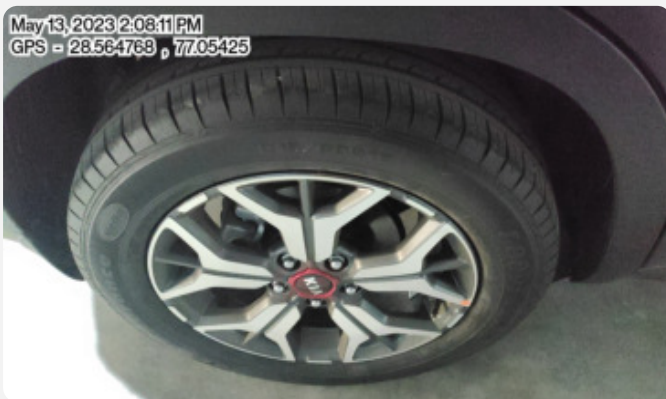
Rear Right Tyre

Condition : **Satisfactory**

40%-60%

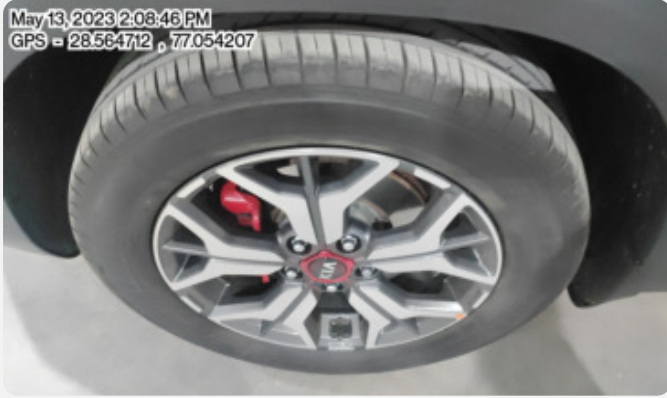
Rear Left Tyre

Condition : **Satisfactory**

40%-60%

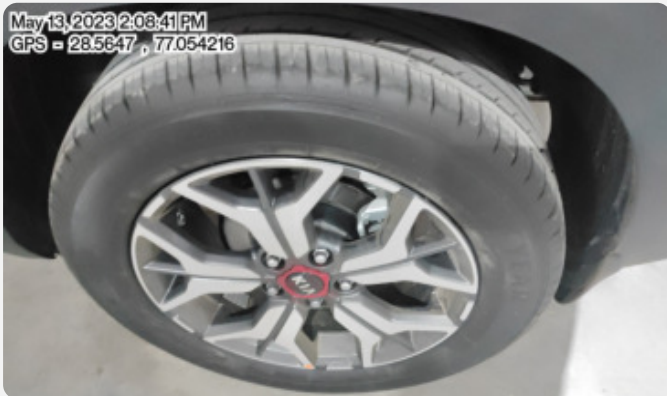
Front Left Tyre

Condition : **Satisfactory**

40%-60%

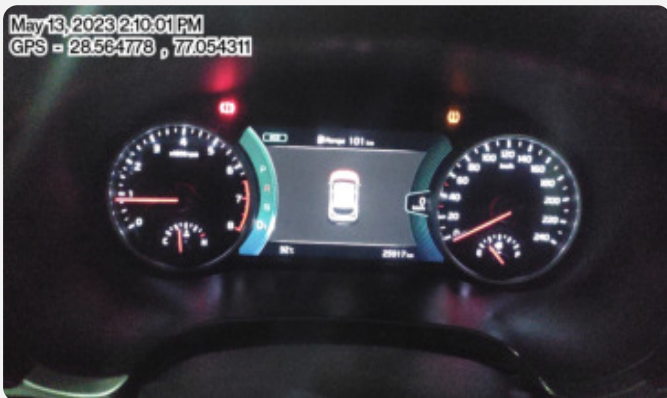
Odometer

Condition : **Excellent**

Good Condition
